**KOMITE NASIONAL KESELAMATAN TRANSPORTASI  
REPUBLIC OF INDONESIA**

**KNKT.18.10.35.04**

## **Aircraft Accident Investigation Report**

**PT. Lion Mentari Airlines  
Boeing 737-8 (MAX); PK-LQP  
Tanjung Karawang, West Java  
Republic of Indonesia  
29 October 2018**

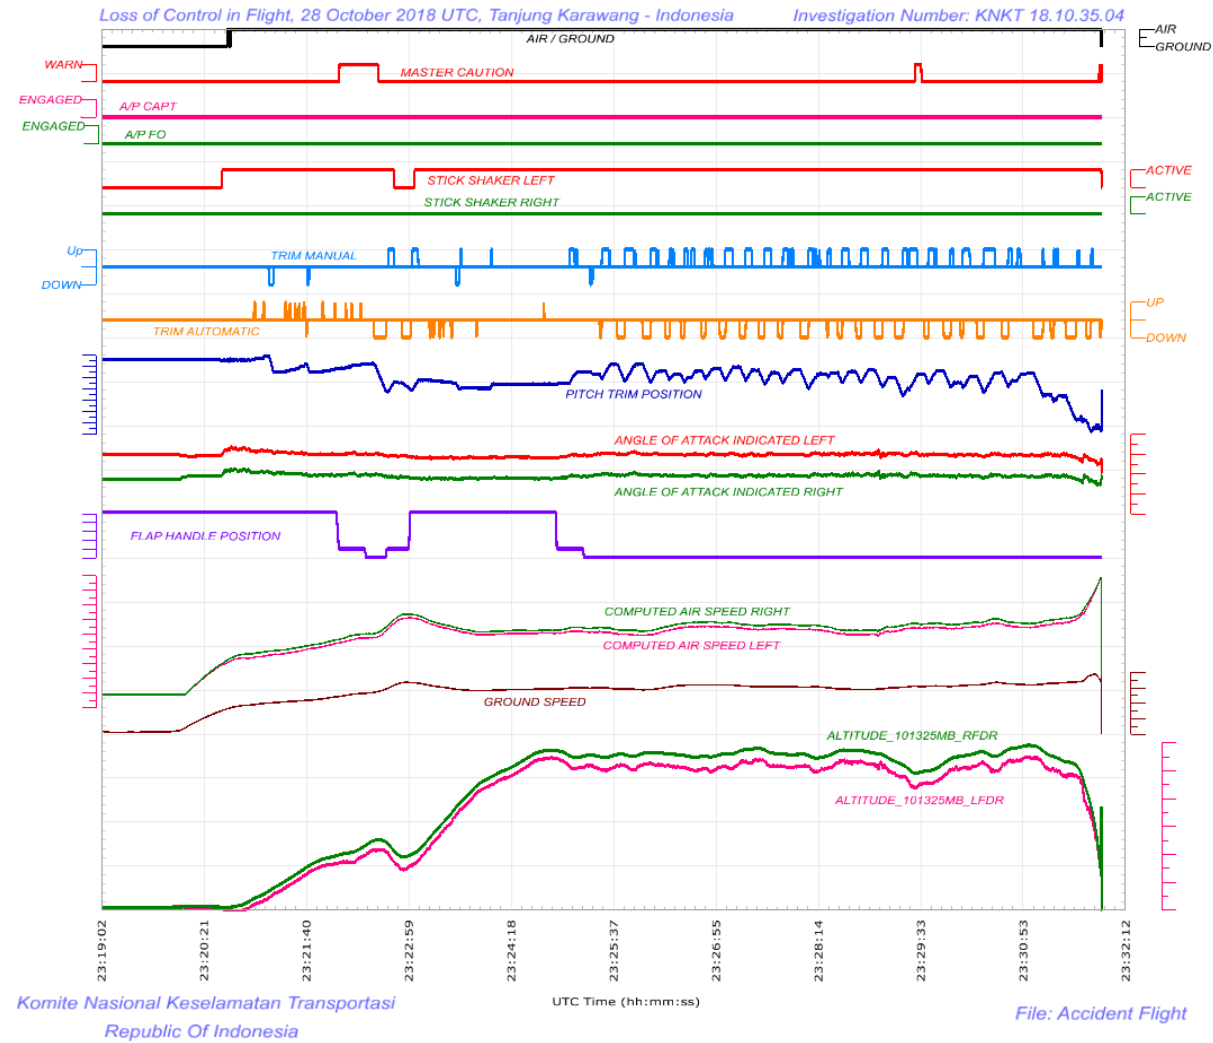
**Figure 5: The significant parameters from the accident flight**

Several significant parameters of the DFDR are shown on the following figures.

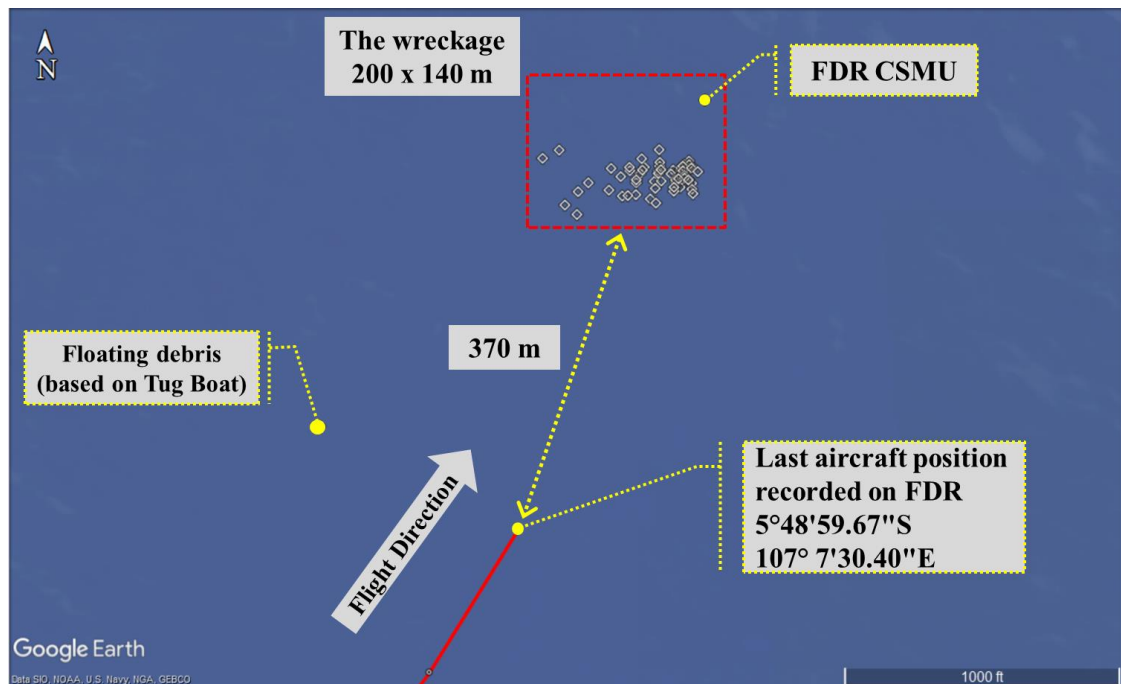
Figure 8: The wreckage distribution

The CSMU was found at 5°48'43.20"S 107°7'37.60"E which was within the wreckage distribution area. Several parts of the aircraft were recovered and transported to Jakarta International Container Terminal (JICT). The wreckage recovered was from all parts of the aircraft from the forward part to the aft part.

The recovered wreckage identified consisted of, but not limited to, the left and right engines, both main landing gears, parts of the empennage, parts of the forward and aft left passenger doors, parts of the wings, a flight crew oxygen bottle, and parts of a circuit breaker panel.

The damage to the aircraft suggested a high energy impact.
