Supreme Court of the State of New York, New York County  
Case No. 654765/2019

**Walmart Inc. (f/k/a Wal-Mart Stores, Inc.) v. Tesla Energy  
Operations, Inc. (f/k/a SolarCity Corporation)**  
Document 1

**SUMMONS**

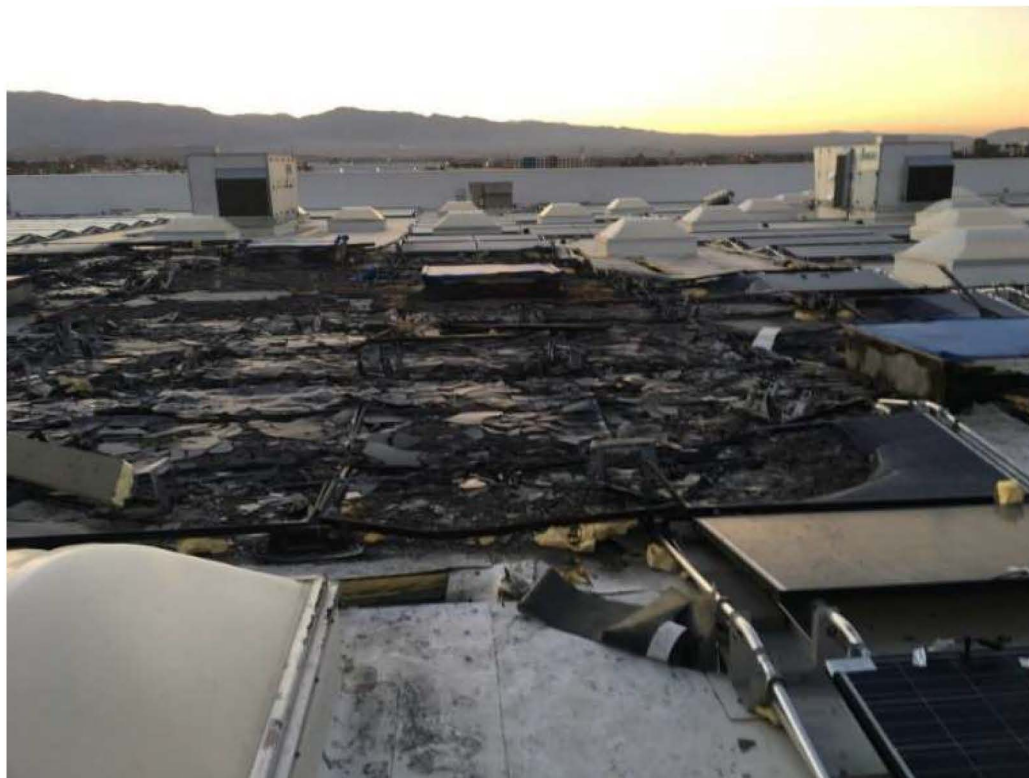
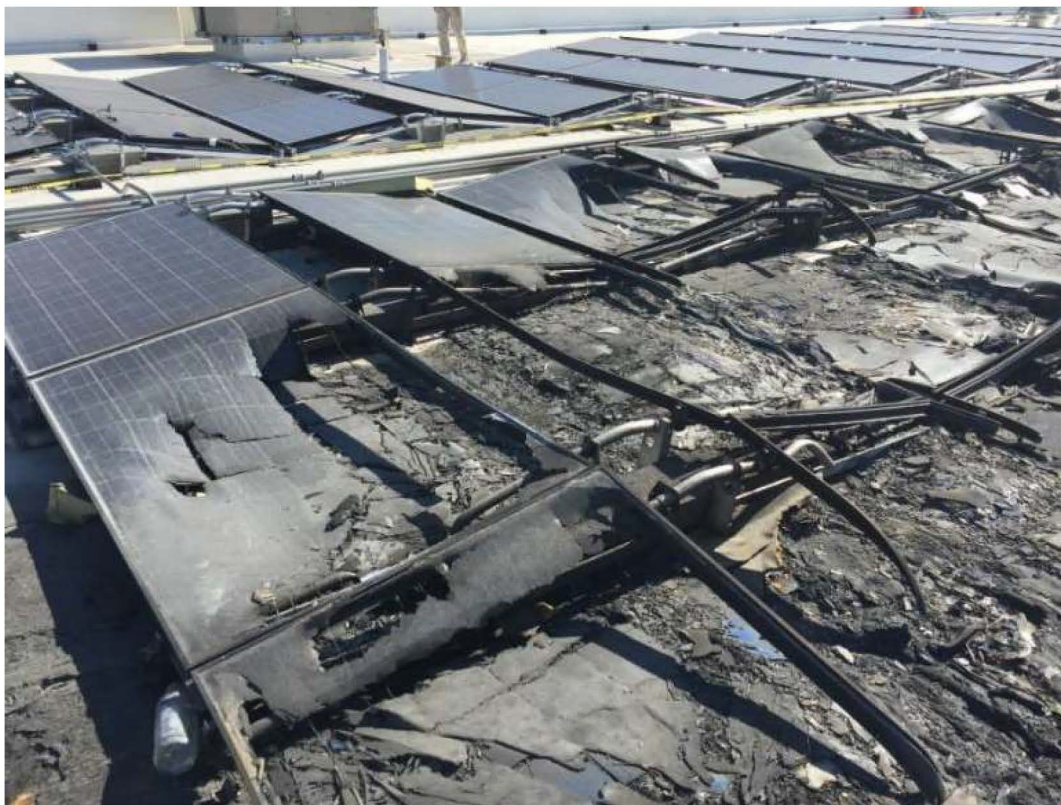
**Images of Indio Fire Damage**

70. Investigation of the Indio fire revealed a number of installation and maintenance issues indicative of pervasive, systemic negligence and conduct that fell far below the standard of Prudent Industry Practices. As described in greater detail below, among the issues identified were module hotspots, improper grounding and wiring methods, improper connector torqueing, and erroneous as-built drawings.

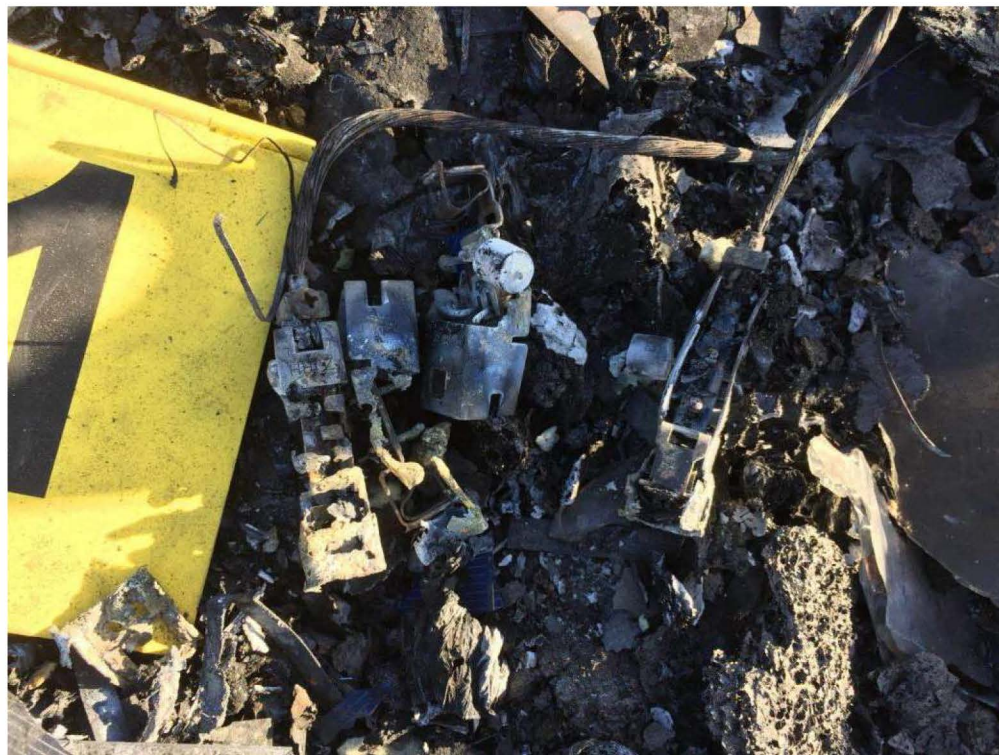
**Module Junction Box at Indio Site (Likely Source of Fire)**

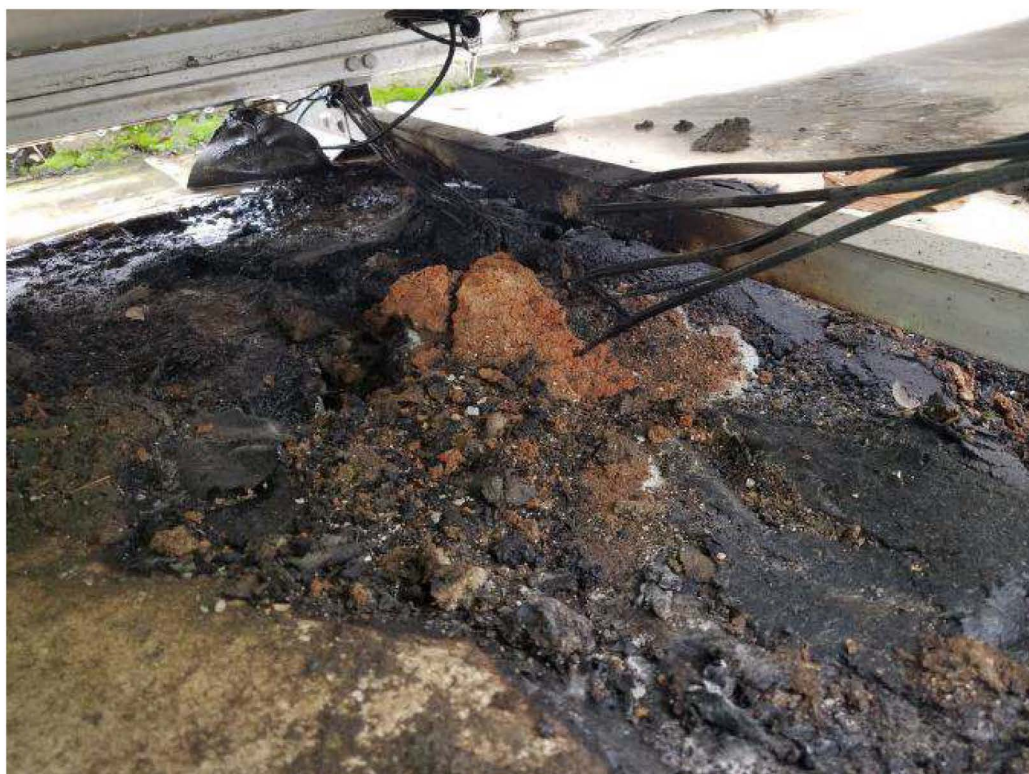
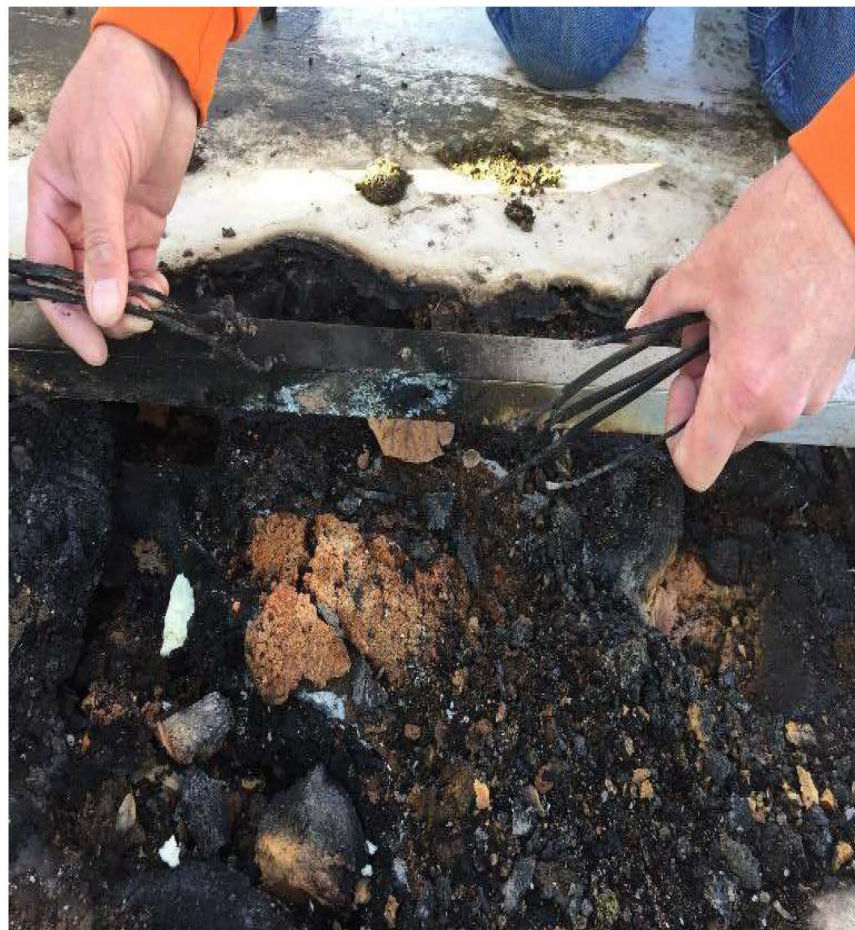
wires were still sparking at the time of discovery, indicating that the fire had occurred recently. Photographs also revealed that arcing had affected numerous wires at the Yuba City site over an extended period of time, degrading the wires' insulation and resulting in the incineration of a substantial section of the store's roof. The extent of the damage to the wires indicated that the fire was sufficiently severe that it could have burned the entire store to the ground. Because of Tesla's failure to provide a final root cause analysis, Walmart has no assurance that the next store to experience a Tesla-caused fire will be so fortunate.

**Images of Yuba City Roof, Evidencing Fire and Arcing**

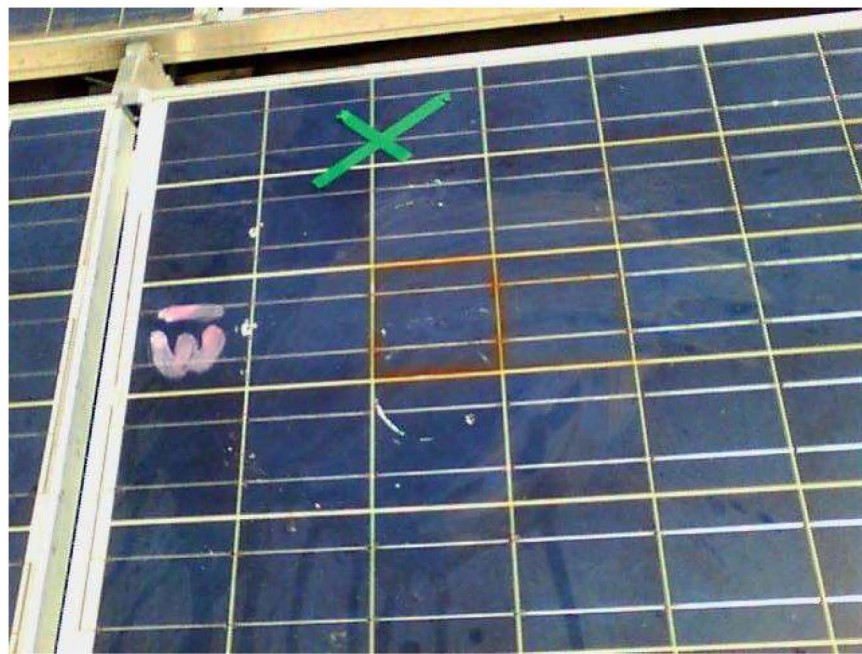
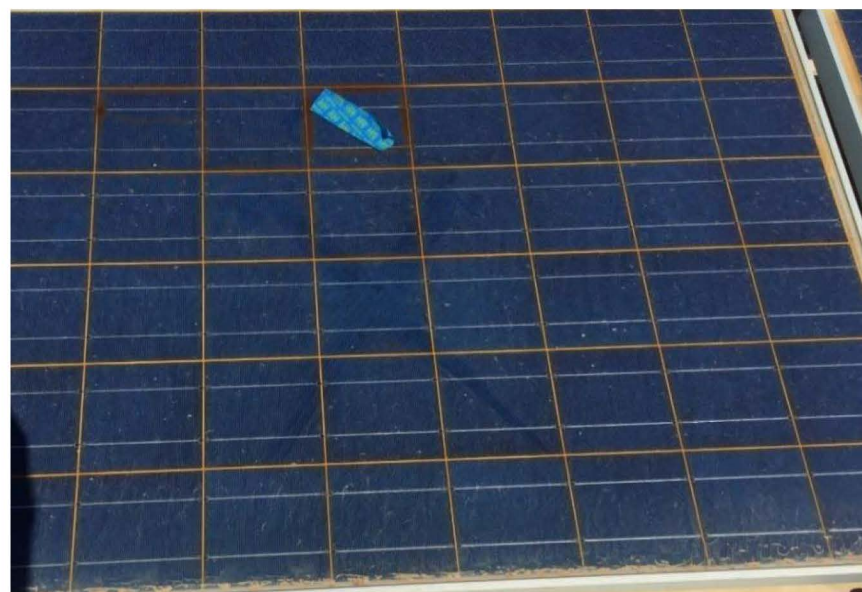
88. Making matters worse, Tesla had flagged or identified hotspots by placing pieces of tape over the affected areas. Because this tape prevented sunlight from reaching the solar panel, it exacerbated the problem by further concentrating heat in certain areas of the solar module—an extremely basic error that a competent inspection team would never have committed.

**Images of Tape Used (Improperly) to Flag Hotspots on Walmart Roofs**

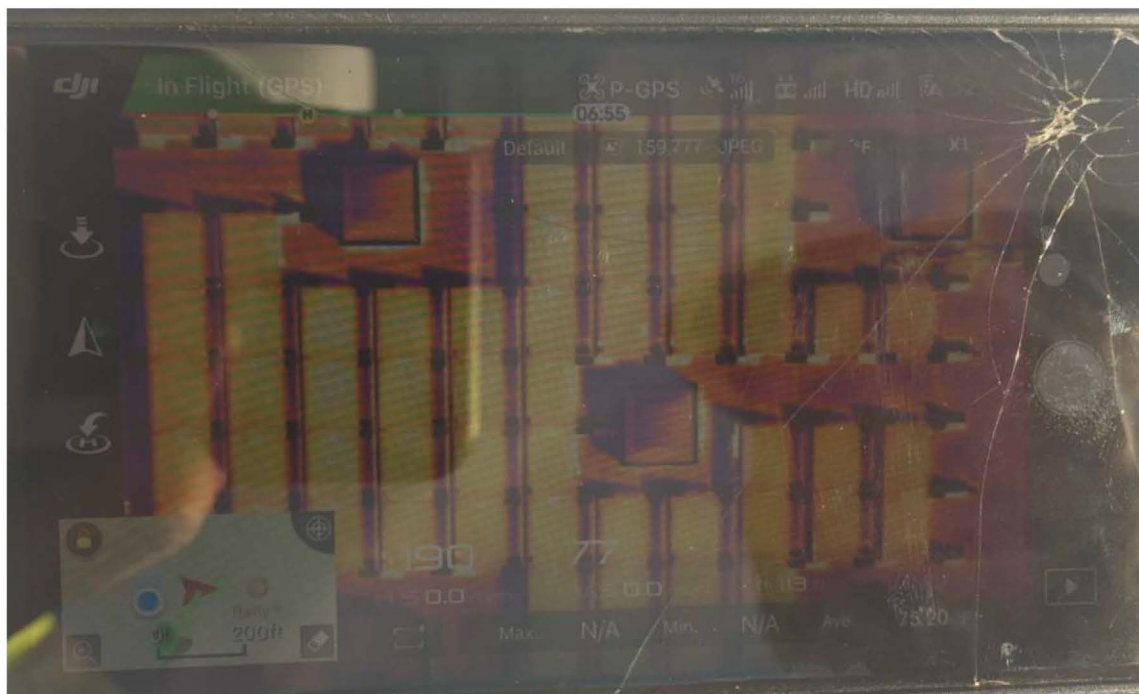
89. Tesla's inspectors also had not implemented proper means of locating and remediating hotspots. They had not adopted uniform standards or directives for identifying hotspots and had not developed criteria to identify when heat differentials between different parts of a module (or different modules) qualified as a hotspot. To locate hotspots, Tesla's inspectors sometimes relied on drones, which generated images of the roofs that lacked sufficient resolution to identify hotspots; as a result, the inspectors missed hotspots that Walmart's consultants found using more reliable methods. On other occasions, Tesla inspectors performed cursory infrared scans from a corner of the roof, but this process did not indicate and would not necessarily have indicated all hotspots across an entire photovoltaic system. Using a thermal gun, a Walmart consultant identified four to six hotspots that Tesla employees had overlooked on just one section of a Walmart roof; one of these hotspots had reached a temperature of over 200 degrees Fahrenheit, as compared to surrounding cells that remained at temperatures of only about 85 degrees Fahrenheit. (The standard temperature differential used to identify a hotspot is a difference of about 60 to 70 degrees Fahrenheit between a solar cell and its surrounding cells. Notably, the solar panels contain plastic components, which begin to degrade at about 160 degrees Fahrenheit.) The hotspots observed during these inspections reflected some of the worst conditions that Walmart's consultants had seen on solar panels over the course of their careers. Some hotspots had resulted in the browning or yellowing of the solar modules and were visible to the naked eye—or should have been, had Tesla's inspectors taken the time to look for them. The conditions were particularly appalling given that hotspots do not develop over the course of one or two days, but rather form over extended periods of time. The prevalence of hotspots on the Tesla systems reflected a long-term pattern of negligence that had gone ignored for years and had not been addressed by proper maintenance procedures.

**Image of Drone Scan Showing Inadequate Resolution**

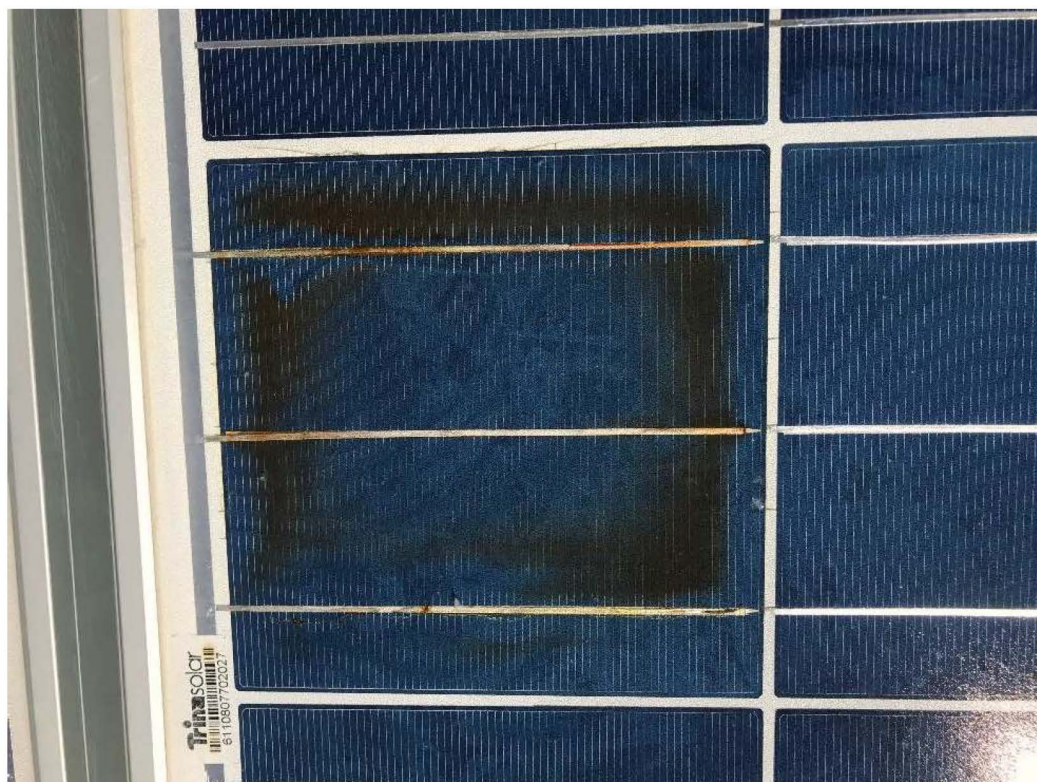
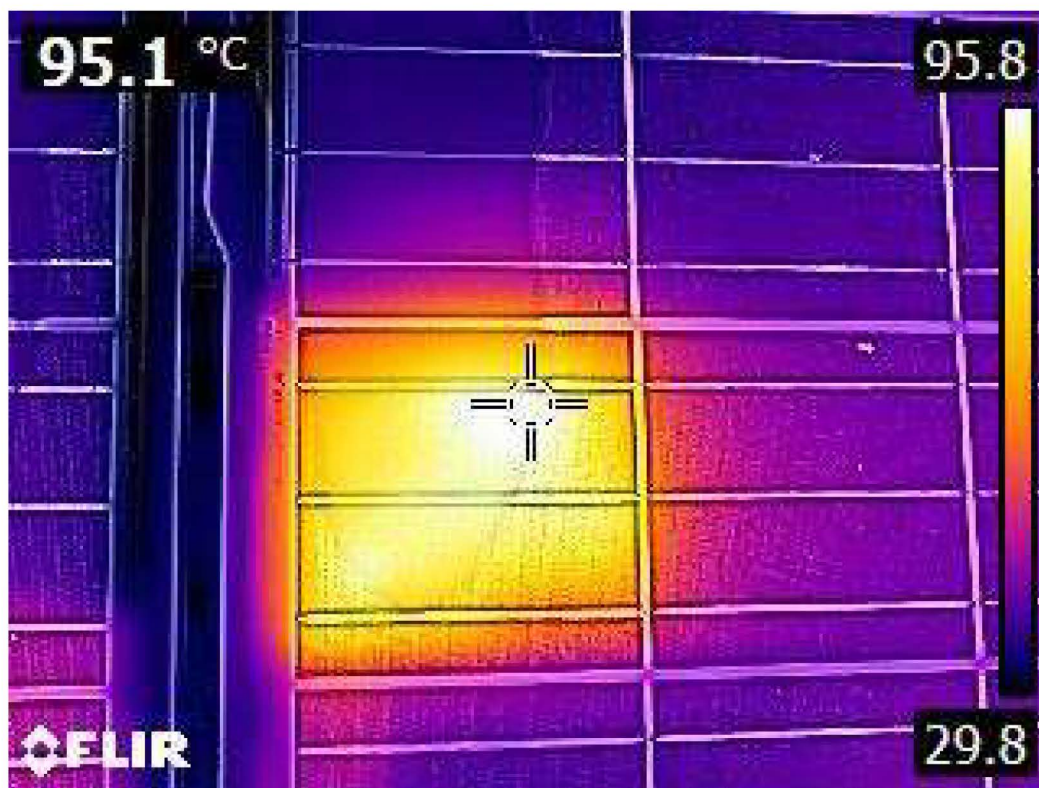
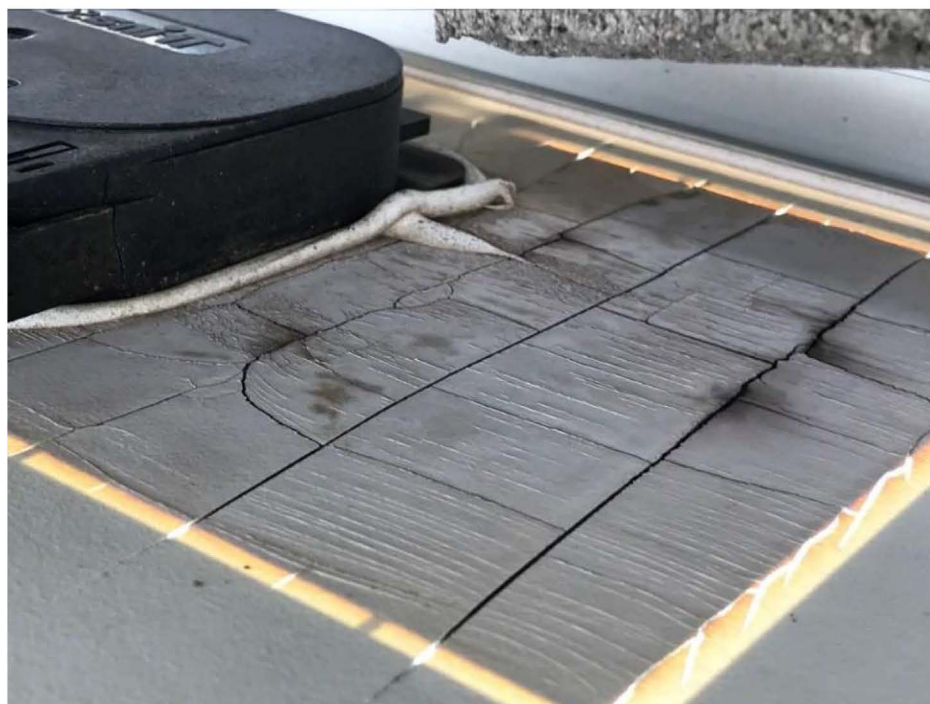
**Images of Hotspots on Solar Modules and Associated Module Cracking**

90. The poor condition of Tesla's solar modules revealed likely explanations for the hotspots that were plaguing Walmart's roofs. Those modules suffered from numerous defects

that are precursors to hotspots, including the yellowing of encapsulant (the adhesive material used to connect components of a solar panel module) and the presence of micro-cracks in the solar modules. Both of those conditions reflect degradation of the solar modules in a manner that might affect bypass diodes and thus contribute to significant heat increases in segments of the solar panel systems.

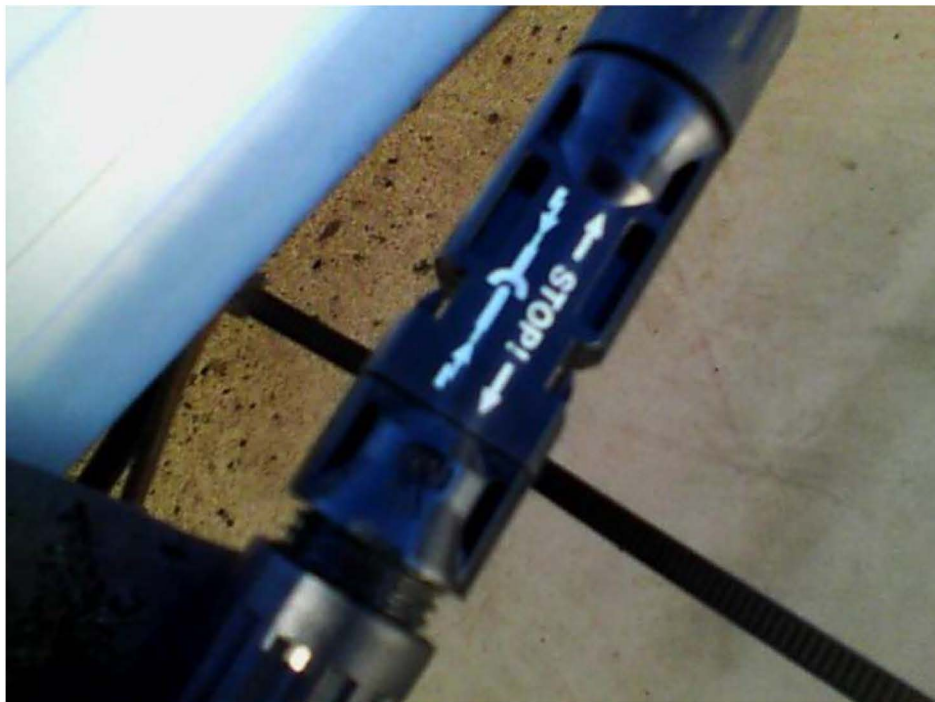
91. The inspections also disclosed evidence that Tesla had negligently installed and maintained connectors, especially field-made connectors, across the inspected sites. For example, some connectors had been “cross-matched,” meaning that incompatible connectors had been used with one another. When connectors are not matched properly, electric current flowing between the connectors is more likely to encounter resistance—and resistance generates heat, which generates fires. In addition, the Tesla teams consistently failed to torque (or tighten) field-made connectors—another basic requirement of the duty of care, Prudent Industry Practices, and manufacturer specifications. To ensure proper torqueing, inspectors should have used a special tool known as an MC4 torque tool. However, some inspectors were using a plastic MC4 tool, which is insufficient to ensure proper torque. Indeed, a Tesla inspector admitted that Tesla was using a plumbing tool (rather than an electrical tool) to tighten connectors, and the standards that this inspector used to determine when a connector was properly torqued did not meet industry threshold requirements. The lack of torqueing leads to moisture and water intrusion. Once these or other substances enter the space where electricity is intended to flow, they may cause the electricity to deviate from its intended path—and, as excessive current is channeled through certain routes, overheating and, eventually, fire are more likely to occur.

**Image of Improperly Threaded Connector**  
*(Threads at Bottom of Image Should Not Be Visible)*

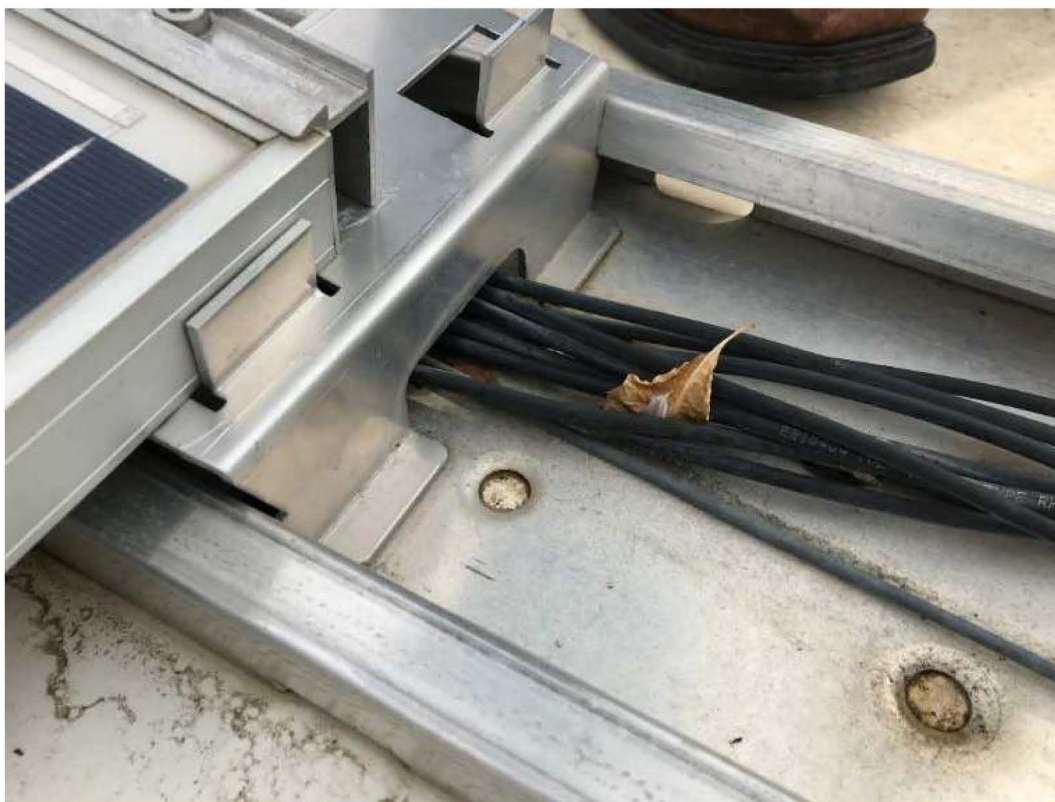
92. Poor wire management practices were also evident at multiple Walmart sites. In some cases, sharp points—from, among other items, rough concrete or metal edges—were cutting into or abrading wires. In other cases, temperature changes resulted in the expansion and contraction of wires over time, moving the wires and resulting in their abrasion or exposure. In still other cases, conduits were overstuffed, containing too many wires to be safely used. And wire insulation failures resulted in the exposure of current-carrying electrical conductors to the elements, creating a substantial safety and fire hazard. By degrading the insulation of the solar panels' wiring, these factors increased the risk that an electric current would deviate from its intended path and cause a fire that would spread to surrounding panels. Many of these issues could have been—but were not—addressed through industry standard maintenance procedures, including resealing or reinsulating exposed wires.

**Image of Wires Exposed to Sharp Edges**

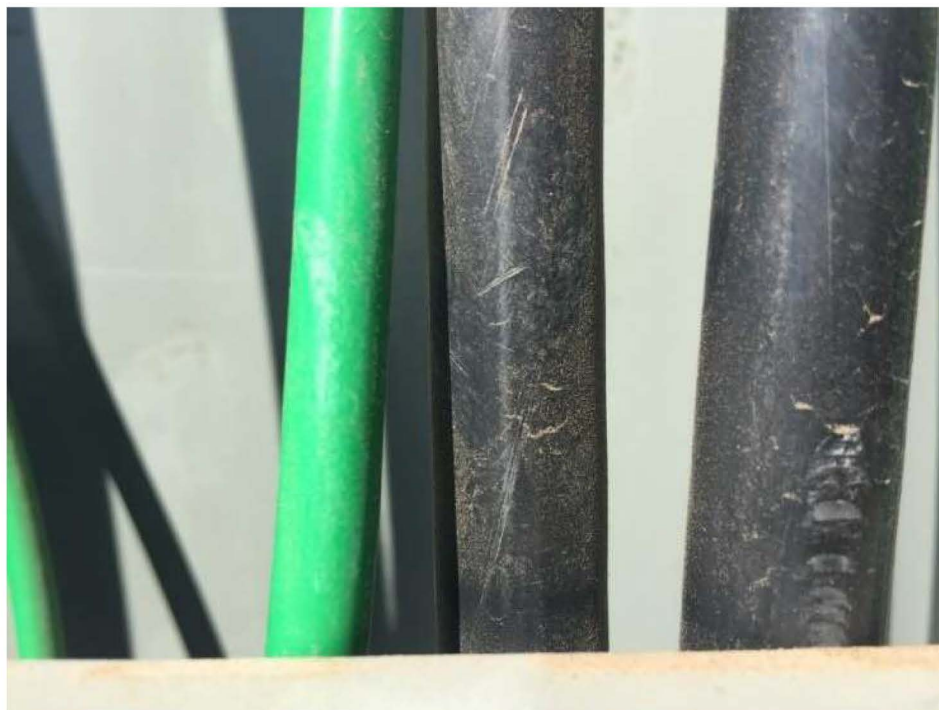
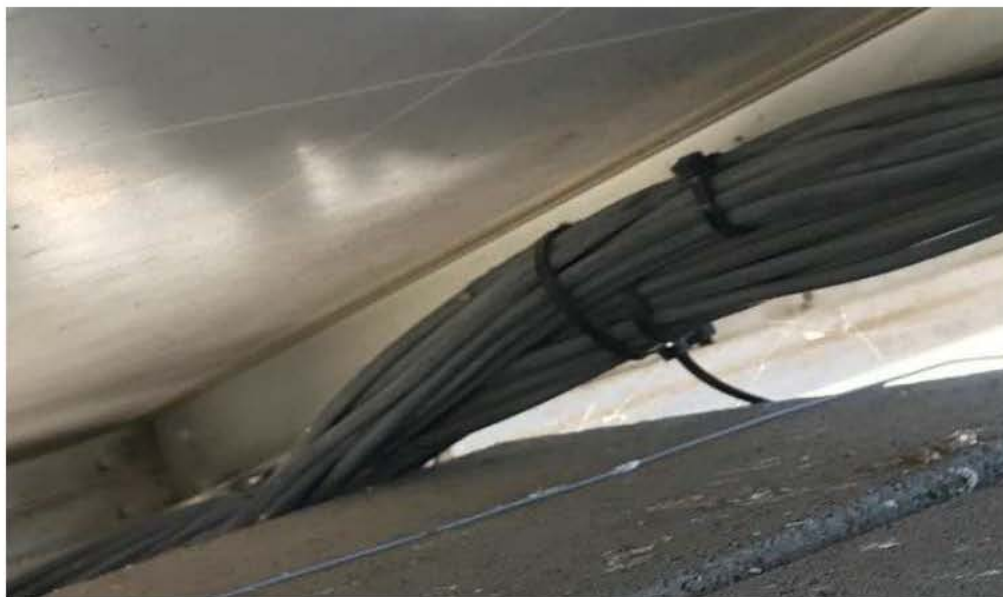
**Images of Abraded Wires**

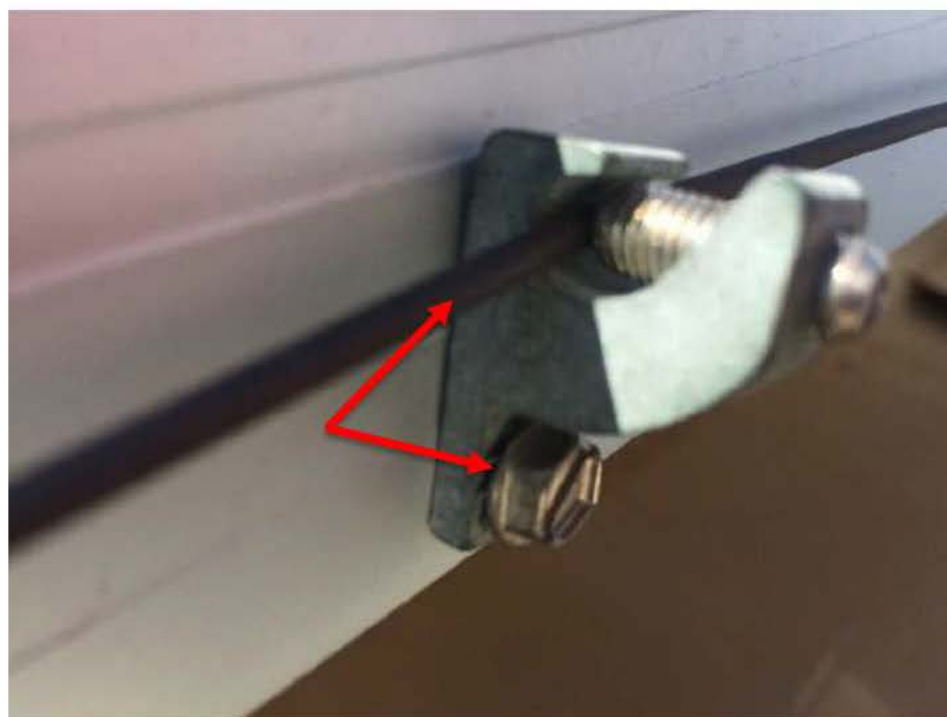
**Image of Improper Module Grounding**  
*(Washer Should be Between Lug and Module Frame)*

93. Walmart's inspections also disclosed evidence of improper grounding at multiple sites. In the context of electrical systems, "grounding" is critical because it provides a reference (or equilibrium) point that ensures the safe production of electric energy. Electricity generally flows from areas with a high amount of potential energy (typically referred to as a "positive terminal") to areas with a lower amount of potential energy (typically referred to as a "negative terminal")—just as gravity causes water to flow from higher to lower places. "Ground" refers to an electrical reference point for a circuit; proper grounding ensures that electric currents do not jump to or interact with metallic items or other conductors that reside near an electric charge. Improper grounding can cause an electric system to trip (i.e., to stop conducting electricity) or to arc (i.e., to experience the flow of electricity through an unintended path); arcing, in turn, may cause insulation to fail and result in fires.

94. With respect to solar photovoltaic systems installed at Walmart stores, proper grounding means that materials conducting electric charges must connect to a grounding electrode outside of the Walmart store. Upon reviewing Tesla's inspections of Walmart stores, however, it became clear that multiple conductors were not properly grounded according to standard principles of electrical systems as outlined in the National Electrical Code. This fact, in conjunction with Tesla's poor wire management practices, demonstrated that Tesla had run afoul of basic industry conventions in the installation, operation, and maintenance of its solar panel systems—and had done so in a way that exposed Walmart stores, customers, and employees to fires.

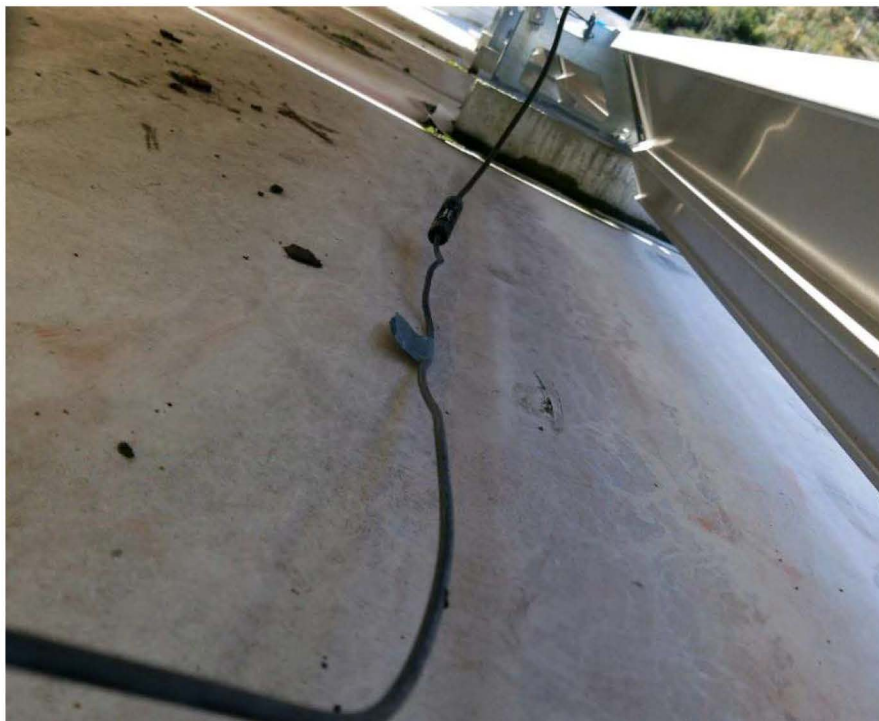
**Image of Wire Improperly in Contact with Roof**

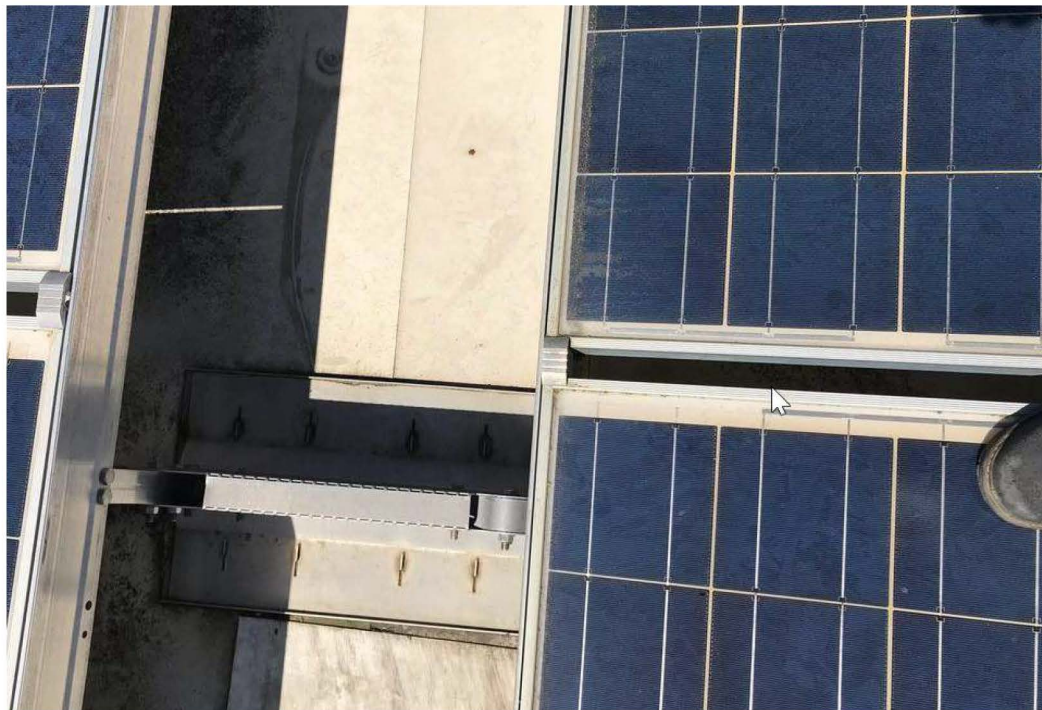
96. Tesla inspection personnel frequently missed or improperly identified obvious and visible risks with the solar panel systems and were often negligent in performing inspections. Most glaringly, Tesla inspection personnel violated elementary safety standards by negligently stepping on modules (potentially contributing to micro-cracks), using the wrong equipment for basic tasks, and—in one instance—leaving a combiner box enclosure open and exposed to the elements after an inspection. Tesla also relied on drone fly-overs and other shortcuts when inspecting sites, rather than sending qualified and properly trained solar inspectors to physically inspect solar panel systems with appropriate equipment—the established industry method for conducting thorough inspections.

**Image of Tesla Inspector Stepping on Solar Modules**  
*(Inspector's Foot Visible in Bottom Right of Image)*
