**NATIONAL TRANSPORTATION SAFETY BOARD  
OFFICE OF HIGHWAY SAFETY  
WASHINGTON, D.C.**

**FACTUAL REPORT OF INVESTIGATION**

Location: Southbound Interstate 405 south of Washington Boulevard, Culver City,  
Los Angeles County, California  
Vehicle 1: 2014 Tesla Model S  
Operator 1: Private Owner  
Vehicle 2: 2006 Seagrave Custom Firetruck (pumper)  
Operator 2: Culver City Fire Department, Culver City, California  
Date and Time: January 22, 2018, at approximately 8:40 a.m. PST  
Injuries: 0  
Fatalities 0  
NTSB #: **HWY18FH004**

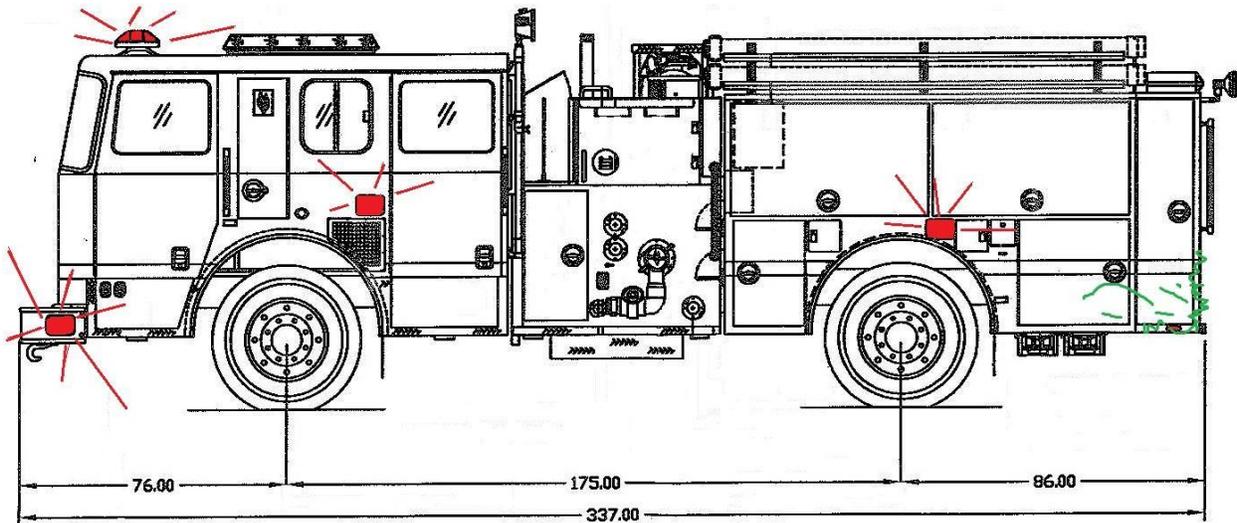
**Figure 1:** The Left Side of the Fire Truck

The crash damage sustained by the firetruck was contained to the left rear of the vehicle, see **Figure 1**. There were numerous gouges, scrapes, and black transfers (green marks), originating at the left-rear corner and extended forward approximately 40-inches along the two left-rear side equipment compartment doors. There was an arched-shaped scrape that apexes the bottom of the door handle on the second-to-last compartment door. The metal trim located on the bottom of the rearmost compartment was damaged and displaced forward. The lower portion of the left-rear corner sustained moderate crush damage.

The exterior lights of the fire truck were inspected for functionality. All of the lights were observed to be functional, including the broken light assembly on the left. In **Figures 1 and 2** above, the emergency lights which would be activated are indicated. The red and yellow markings on the rear compartment doors are comprised of reflective tape.

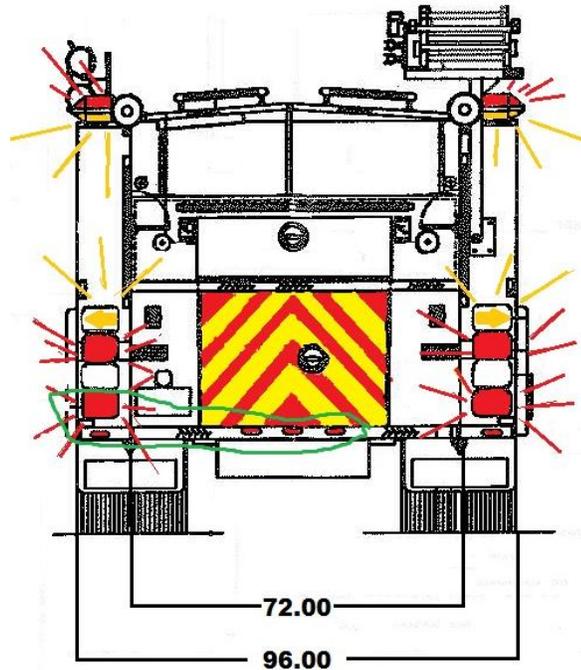
**Figure 2:** The Rear of the Fire truck

The rear of the fire truck sustained crash damage as well. Most of the damage was located to the left of center of the vehicle; see **Figure 2**. The lower portion of the equipment compartment door, the left of the rear deck, sustained impact damage. The left-lower, red, Light Emitting Diode (LED), lens was crushed. The rear deck, which was 72-inches wide, sustained crash damage from the left to the right, approximately 50-inches in width. The left side of the rear deck was distorted in an upward arch – preventing the rear compartment doors from opening. The three red LED

identification lights mounted to the rear deck, were displaced forward beneath the rear deck. The green outline in **Figure 2** illustrates the area of damage.
