Investigation report On the fire in the OVH data

storage center

Iocated in Strasbourg (67) on March 10, 2021.

Author organization: Bureau of Investigation and Analysis of Industrial Risks (BEA-RI) Document title: Investigation report on the fire in the OVH data storage center located in Strasbourg (67) on March 10, 2021 No.: MTE-BEARI-2022-005 Report date: 05/24/2022 Suggested keywords: fire, datacenter, batteries, data storage, UPS.

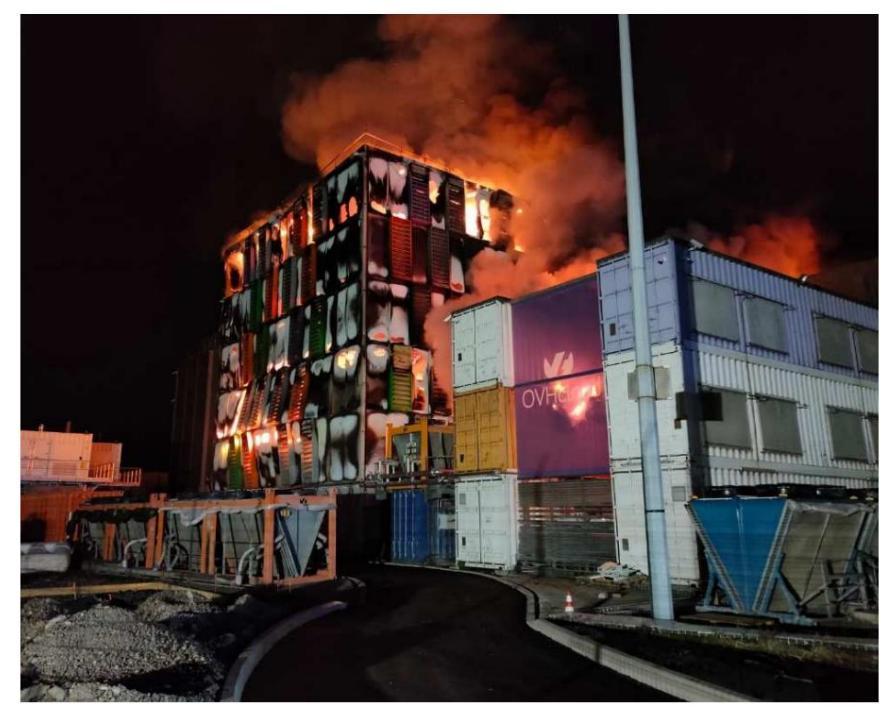
Photograph 1: site during the fire (source SIS 67)

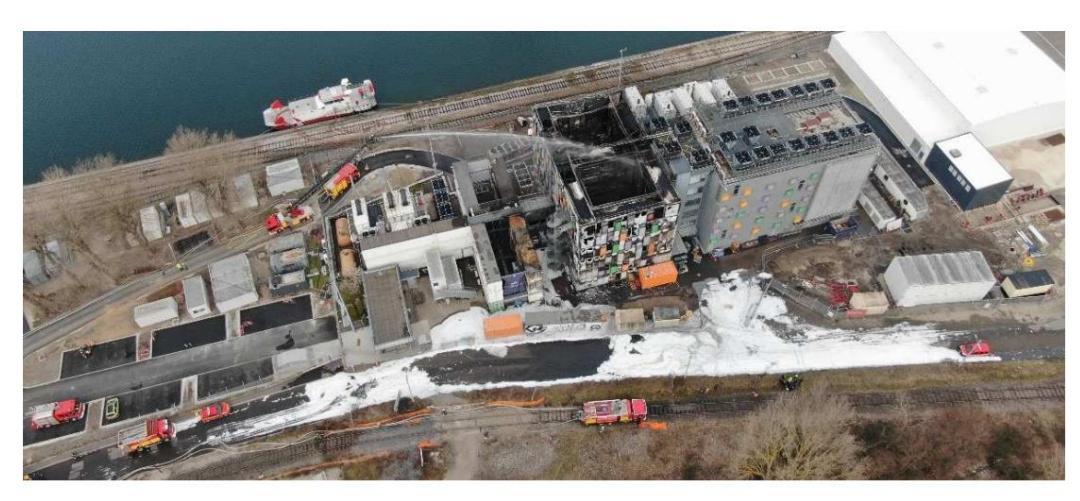
The fire caused no casualties and no injuries. On the other hand, it caused significant material and financial damage. It caused the total destruction of the SBG2 building and the partial destruction of the SBG1 building (4 rooms).

Photograph 2: site the day after the fire (source SIS 67)

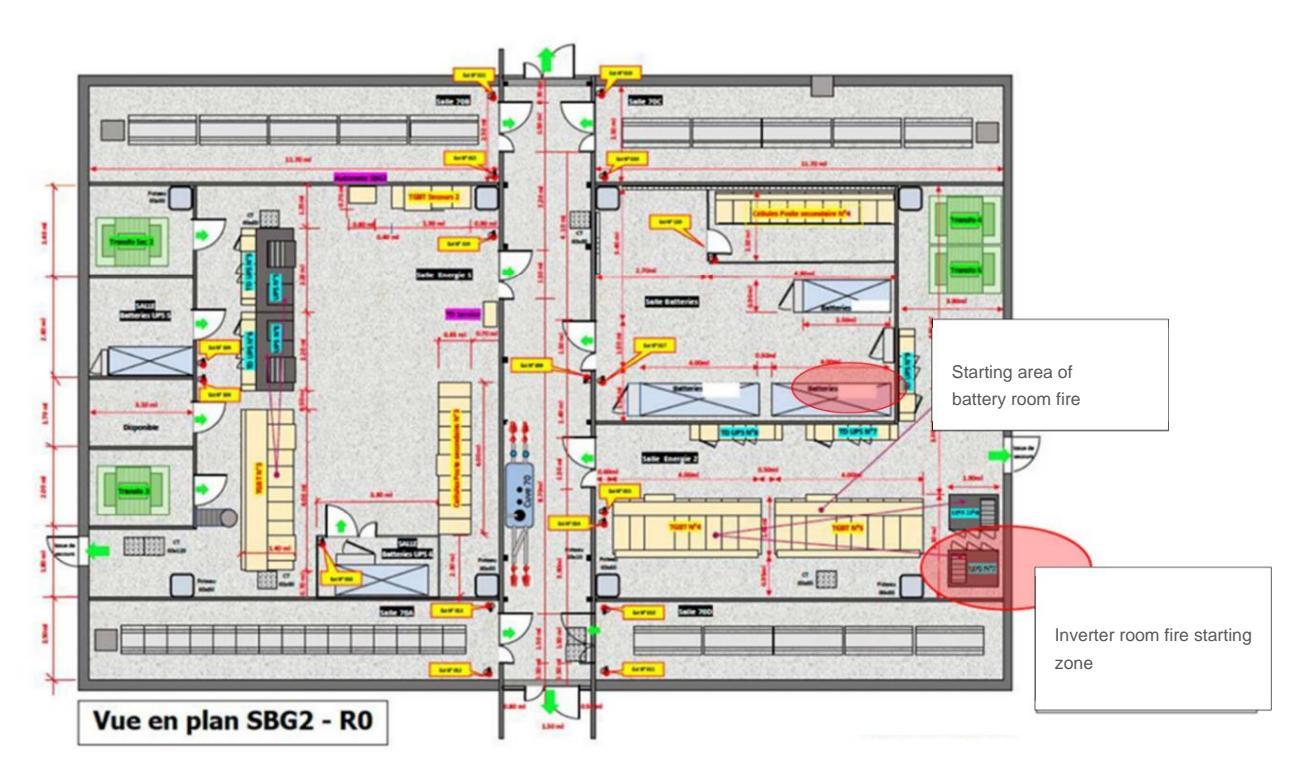
Figure 7: R0 plan of the SBG2 building (OVH source plan). The fire starting zone was added by the BEA-RI in order to improve the readability of the plan and the understanding of the text. (The same plan on a larger scale is shown in appendix 3)

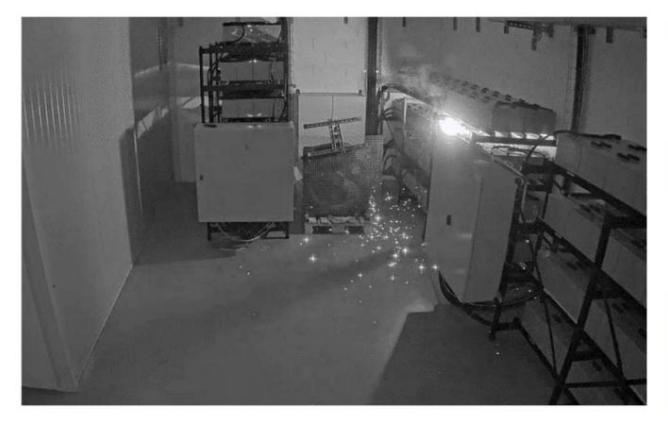
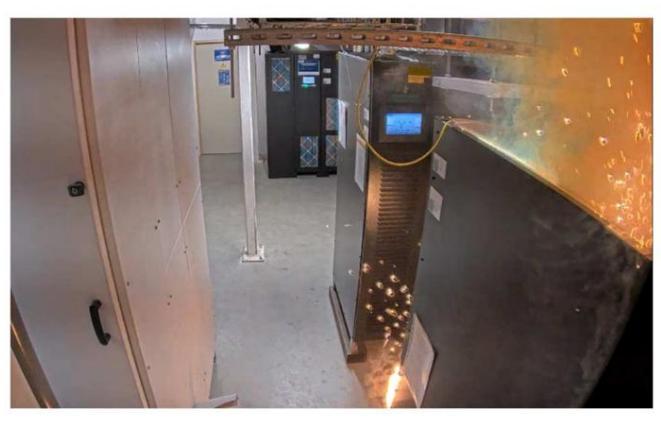
The video surveillance system and the monitoring of the site's fire control panel show that an electrical fault has occurred at the level of the UPS2 and at the level of the batteries connected to it. The UPS and associated batteries were not in the same room.

Photograph 7: 12:35 a.m., outbreak of fire in UPS2 (source: image taken from OVH video surveillance)

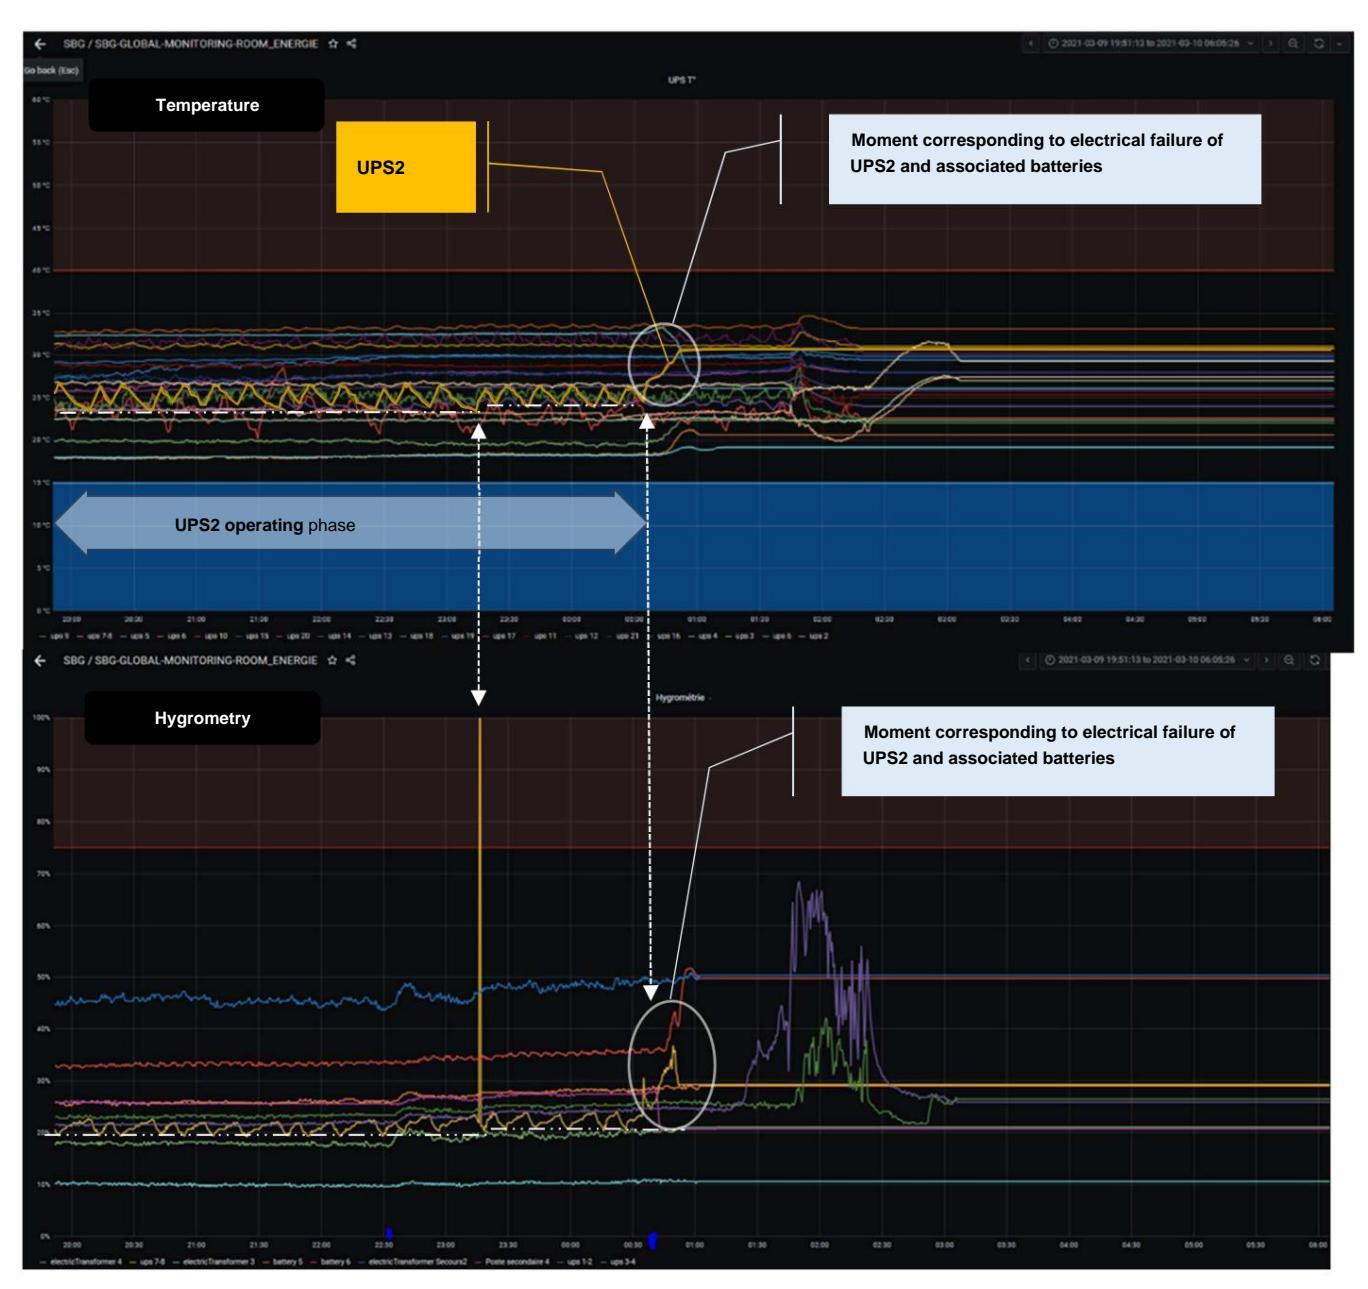
The analysis of the ambient parameters reported in Figure 8 (temperature and humidity measured on sensors located on the rear face of the inverters) leads to the observation of a singular humidity measurement around 11:15 p.m. and a further increase in it shortly after 12:30 a.m. The BEA was unable to establish whether it was a measurement error or a humidity peak linked, for example, to the presence of liquid. Nevertheless, we find that from the 11:15 p.m. measurement:

- At the level of the recording of the ambient temperature, the minimum temperature increases slightly (24°C) compared to the previous phase of temperature variation cycles which evolves between Max 25.5°C Min 23.5 °C;
- At the level of hygrometric measurements, the humidity rate is experiencing a new significant clearly more marked increase from 12:30 a.m.;
- The failure of the inverter is reflected in the temperature curve by a continuous increase and by a new hygrometric peak.

The presence of a liquid or moisture in an electrical device can cause the formation of an internal short circuit likely to cause the damage observed. However, these elements alone do not allow however, not to determine the cause of the failure.

Figure 8: Temperature and humidity readings on the site at the UPS2 level (source OVH)

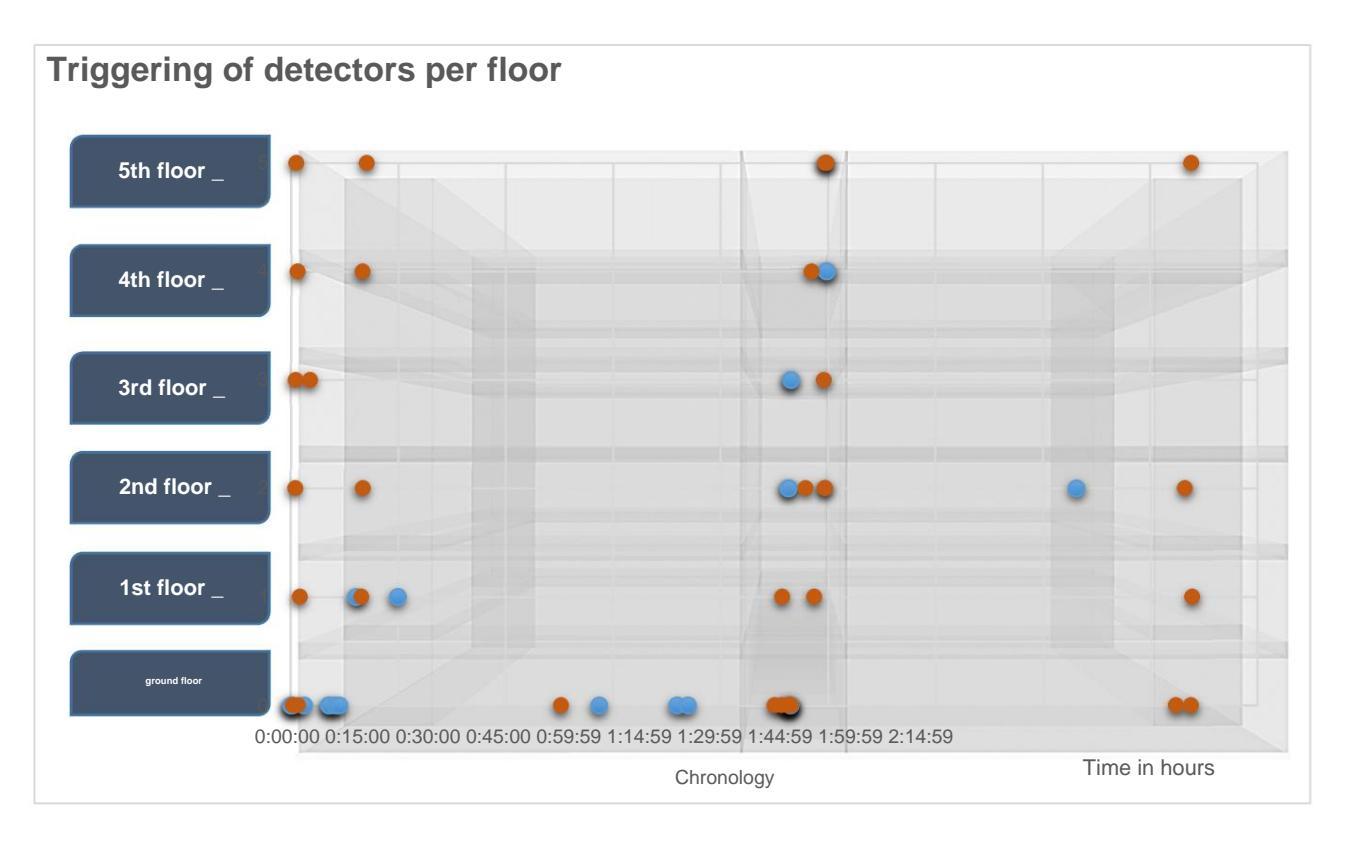
Table 1: Chronology of triggering of fire detectors within SBG2. At t+15 minutes, smoke was detected on all floors by the aspirating smoke detection sensors (orange dots). At t+1 hour, the SIS signals the flashover of the first level, a new series of detectors are triggered in the upper levels and the first optical detectors (in blue) of the second floor are triggered.

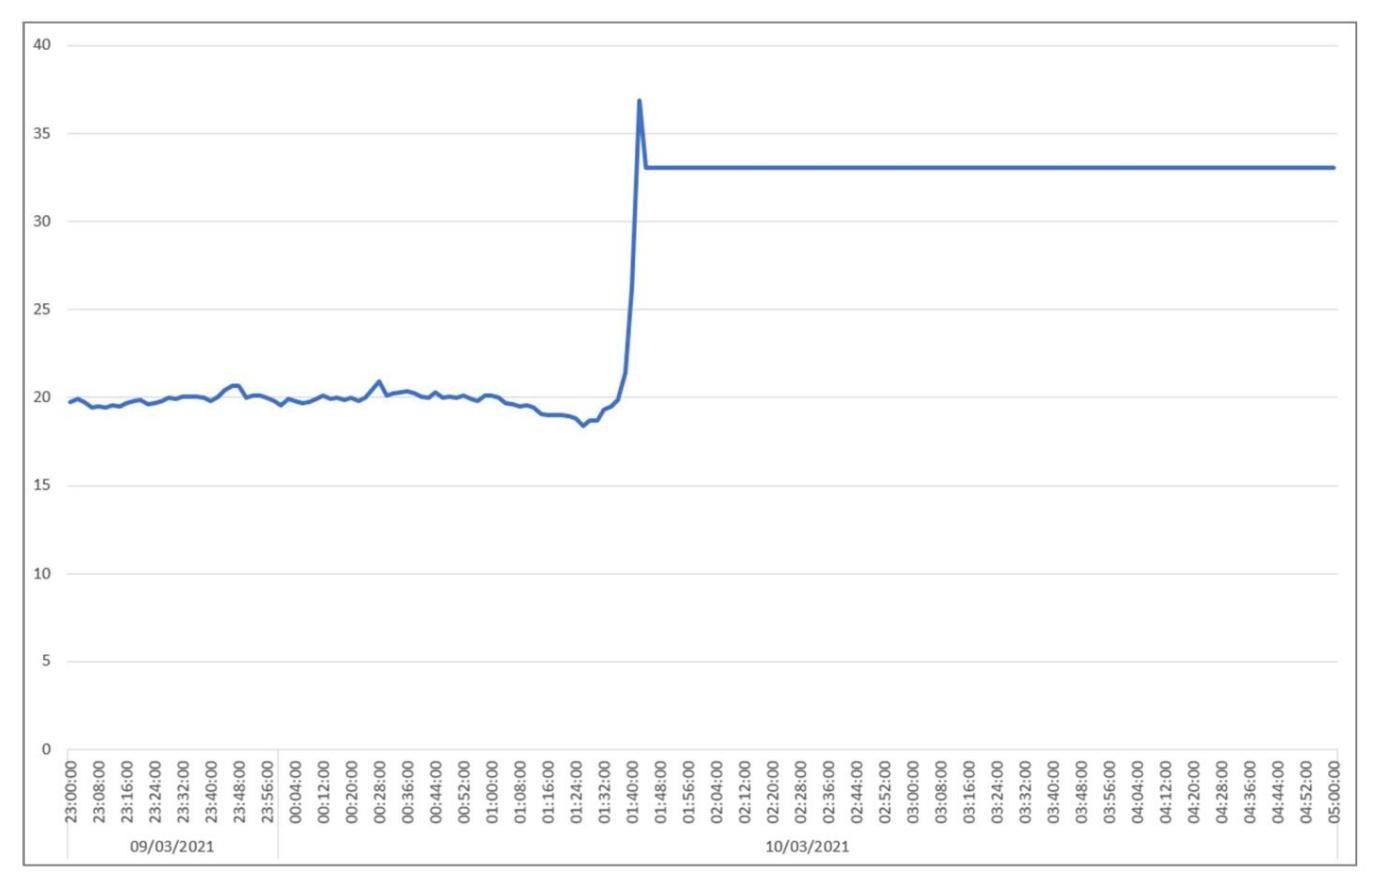
At 1:28 a.m., less than an hour after the first alarm went off, the firefighters reported the spread of the fire to the entire first floor. At 1:40 a.m., the temperature sensors saturate on the second floor, i.e.

Figure 9: temperature curve measured by an SBG2 wing B second floor ambient sensor which shows an abnormal rise in temperature around 1:40 a.m.

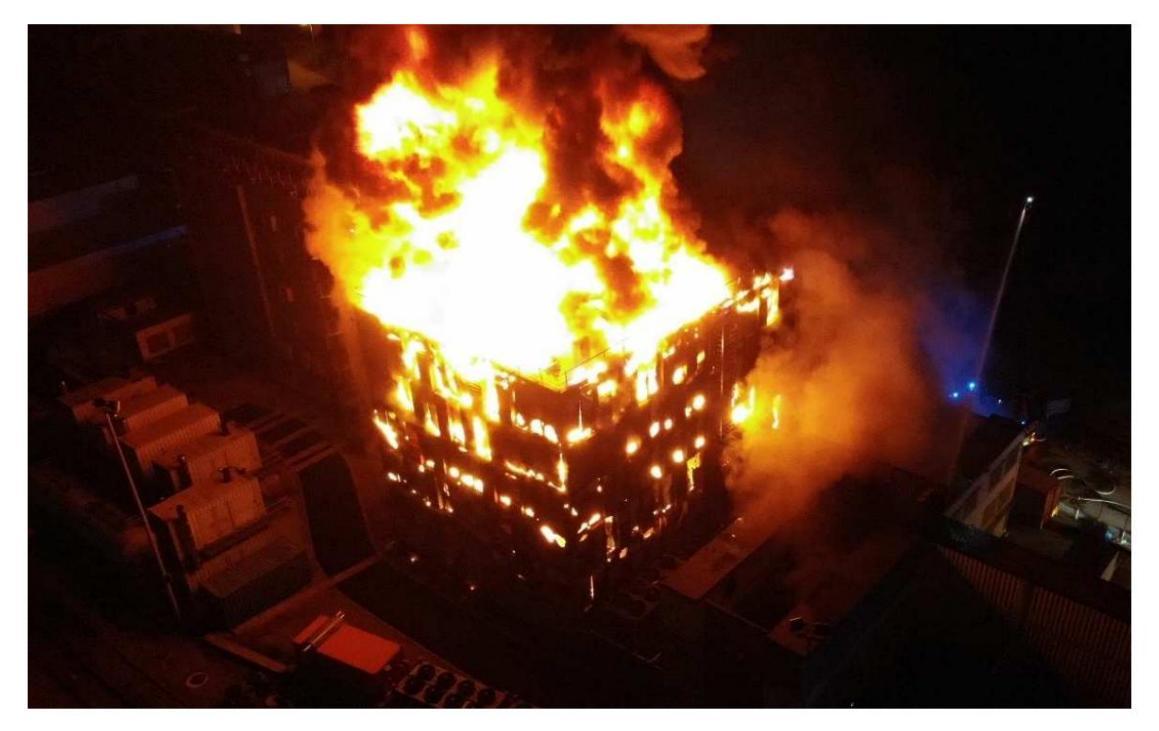
At 2:00 a.m., nearly an hour and a half after the first alarm was triggered, the firefighters reported the generalized conflagration of SBG2. The photo below gives an overview of the situation at 2:50 a.m., 2 hours and 20 minutes after the start of the fire.

Photograph 8: Photograph of SBG2 at t0 + 140 min (Source: SIS 67)

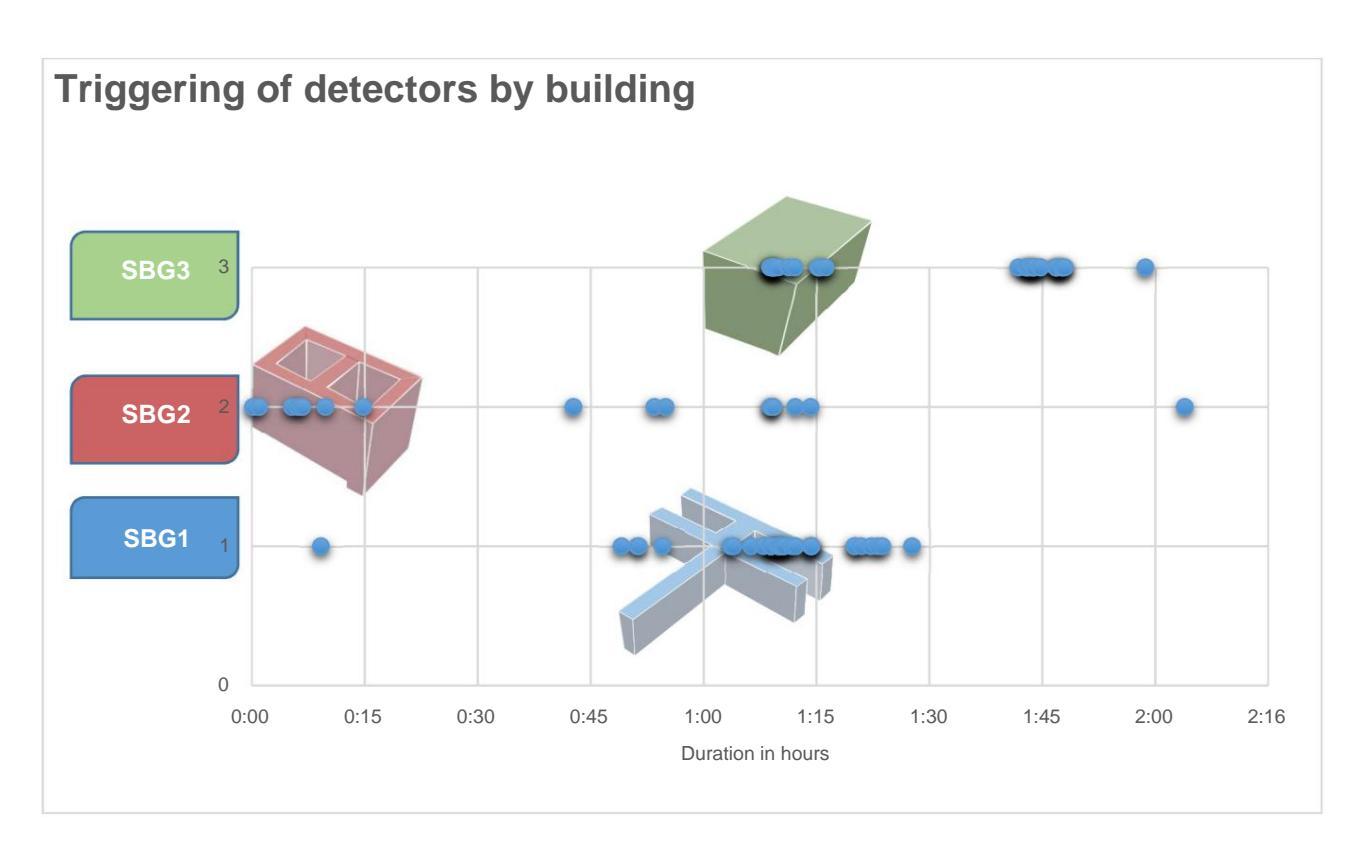
Examination of the timing of the triggering of the detectors of the neighboring buildings shows that it takes between an hour and an hour and a quarter for the optical detectors and the aspirating detectors to trigger significantly in the buildings SBG1 (1st floor) and SBG3.

Table 2: Chronology of triggering of optical detectors within the buildings of the OVH site. We see a first series of triggers during the first 15 minutes on SBG2, followed by triggers on SBG1 (t0+50 min) then on SBG3 (t0+70 min). The triggering on SBG1 during the first fifteen minutes is due to the triggering of a sensor in traffic.

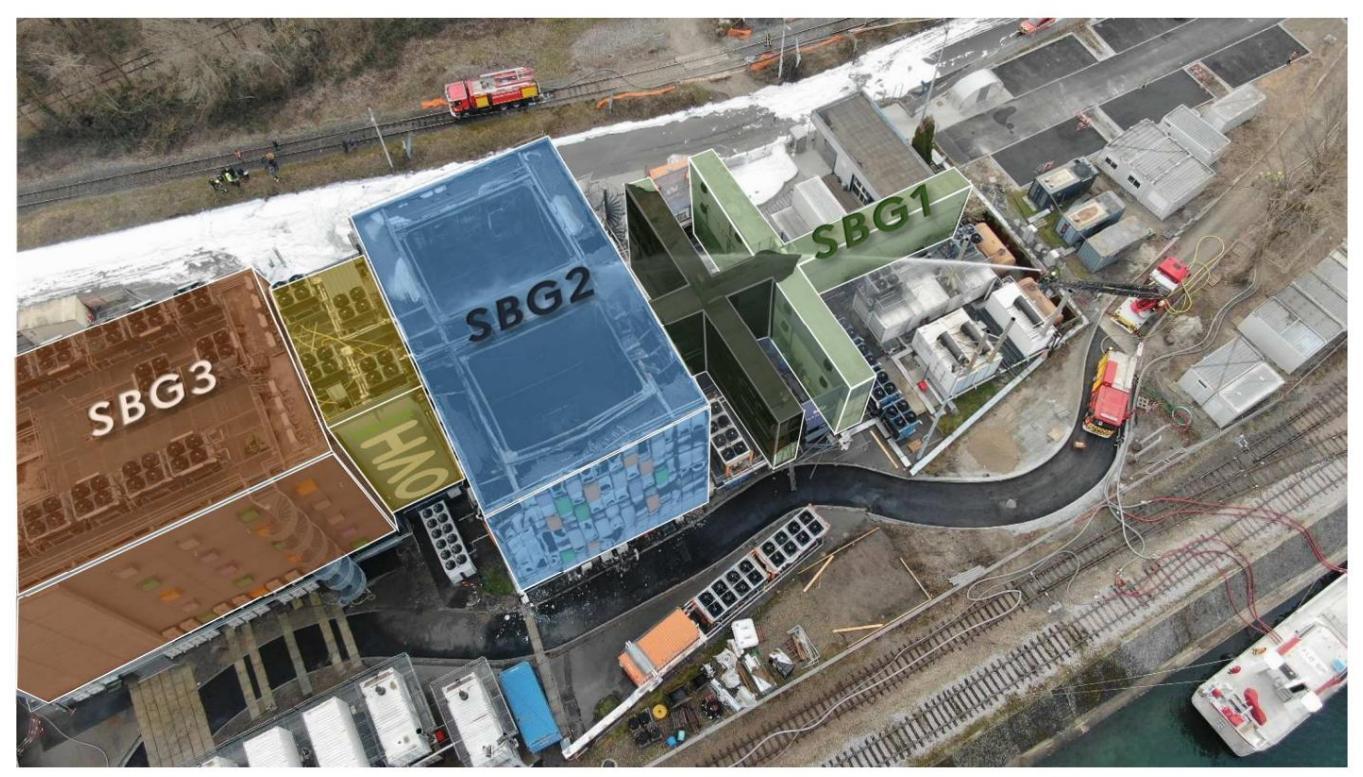
Although the SBG1 and SBG3 buildings have different technical and dimensional characteristics, we note however that SBG3, protected from SBG2 by 2-hour fire walls and by a separation (interbuilding zone made up of circulations), was less impacted than SBG1 which did not have the same level of protection (4 rooms destroyed out of 12). However, the emergency services reported to us that fire doors had been kept open during the evacuation, which had the effect of degrading the effectiveness of this system.

Photograph 9: aerial view of SBG3 (in brown), SBG2 (in blue) and SBG1 (in green). SBG1, smaller in size than SBG2, was directly exposed to heat flows from the SBG2 fire. SBG3 separated by a construction (in yellow) comprising stairs and technical spaces and of comparable size was further protected from the fire. In dark color appears the area of SBG1 affected by the fire.

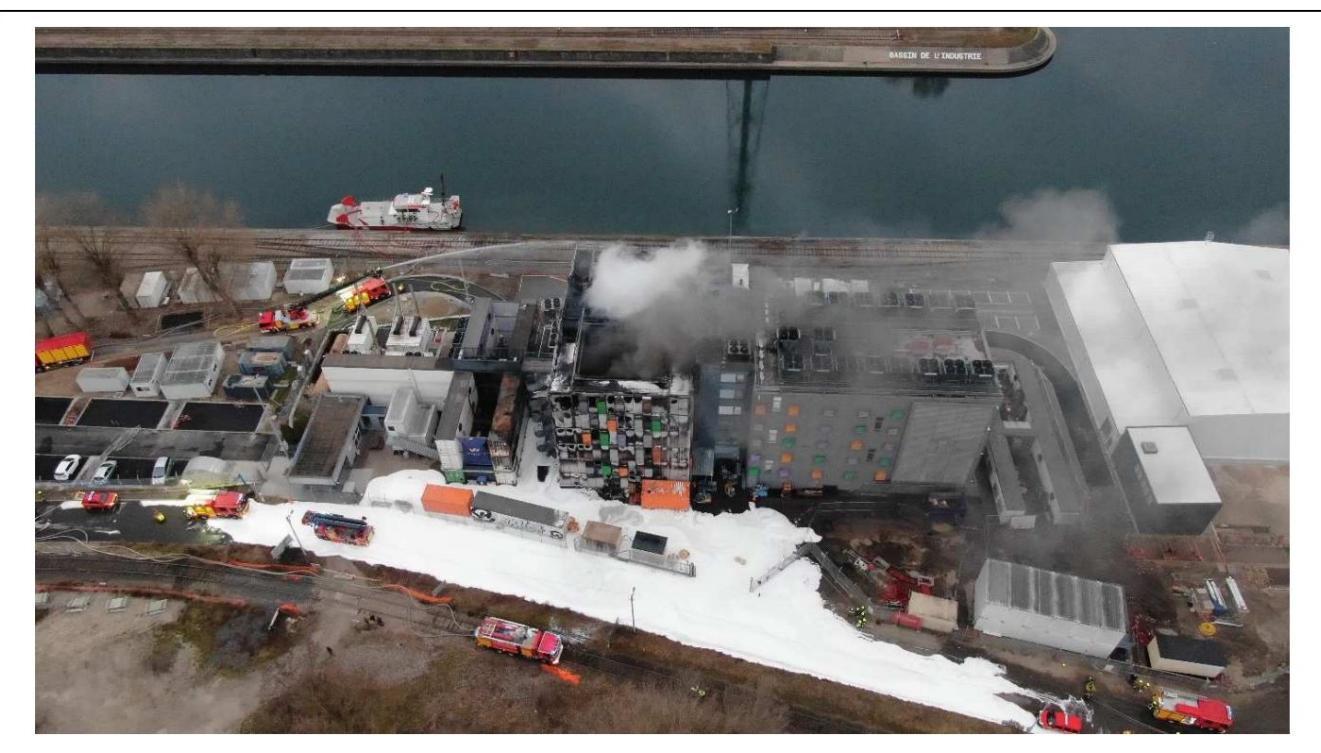
Photograph 15: view of the OVH site at 6:47 a.m. on March 10, 2021 (source SIS 67)
