**KOMITE NASIONAL KESELAMATAN TRANSPORTASI  
REPUBLIC OF INDONESIA**

**KNKT.18.10.35.04**

## **Aircraft Accident Investigation Report**

**PT. Lion Mentari Airlines  
Boeing 737-8 (MAX); PK-LQP  
Tanjung Karawang, West Java  
Republic of Indonesia  
29 October 2018**

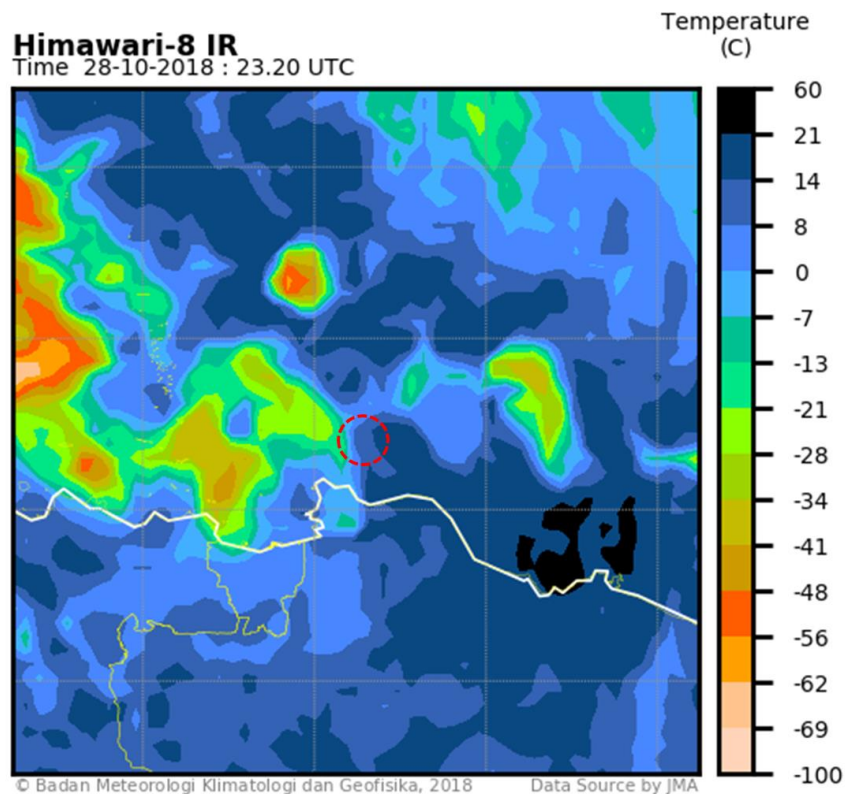
**Figure 1: Enhanced infrared satellite image at 2320 UTC (0620 LT)**

The *Badan Meteorologi Klimatologi dan Geofisika* (BMKG – Bureau of Meteorology, Climatology and Geophysics) provided enhanced infrared satellite images. The enhanced infrared satellite images at 2320 UTC (0620 LT) up to 2330 UTC (0630 LT) indicated that the temperature at the accident site (red circle) was from 0 up to 8°C.

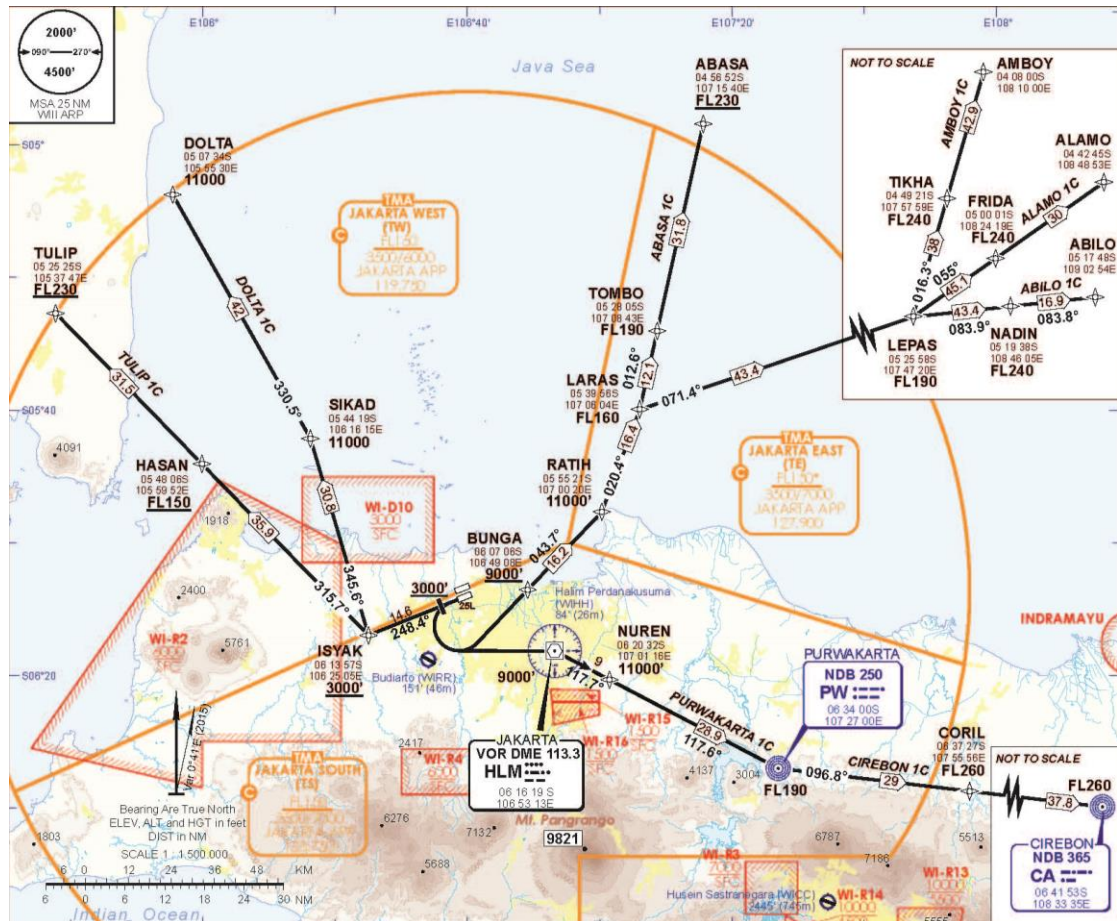
**Figure 3: The RNAV-1 runway 25L (extract from AIP Volume II)**

The runway 25L utilized RNAV-1 Standard Instrument Departure (SID), one of the SID was ABASA 1C which is after departure the pilot has to climb on heading 248.4°, at or above 3,000 feet then turn left direct to BUNGA – RATIH – LARAS – TOMBO – ABASA (figure 3).

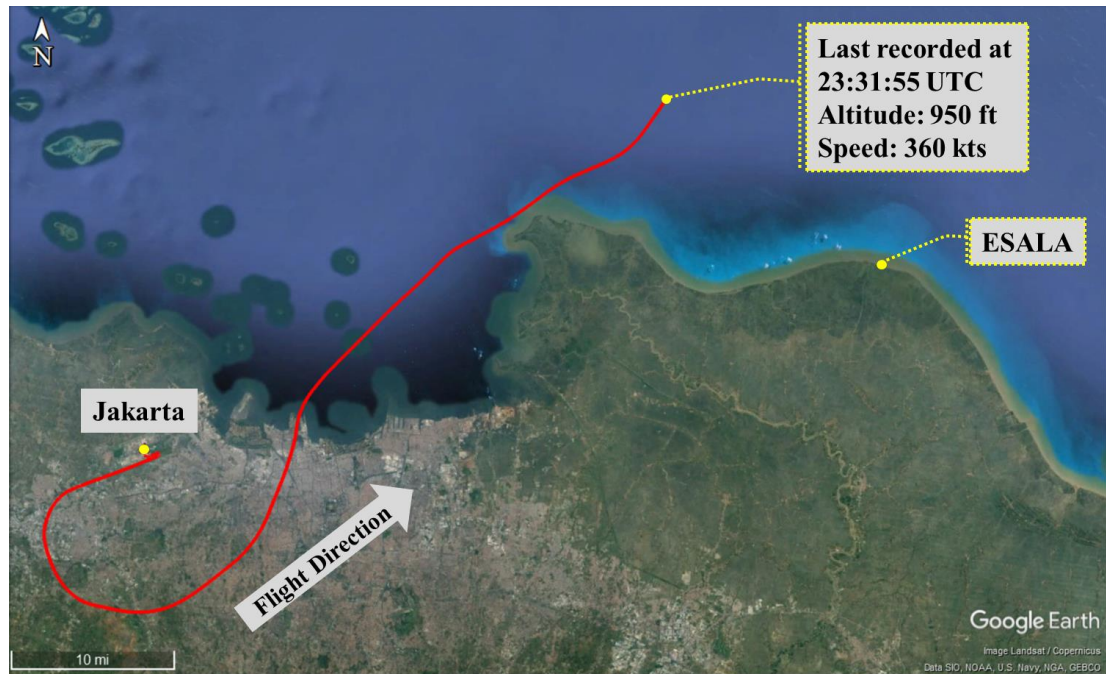
**Figure 4: The flight track of LNI610 based on ADS-B**

The flight track of the LNI610 based on the ADS-B data superimposed on Google Earth.
