Investigation report On the fire in the OVH data

storage center

Iocated in Strasbourg (67) on March 10, 2021.

Author organization: Bureau of Investigation and Analysis of Industrial Risks (BEA-RI) Document title: Investigation report on the fire in the OVH data storage center located in Strasbourg (67) on March 10, 2021 No.: MTE-BEARI-2022-005 Report date: 05/24/2022 Suggested keywords: fire, datacenter, batteries, data storage, UPS.

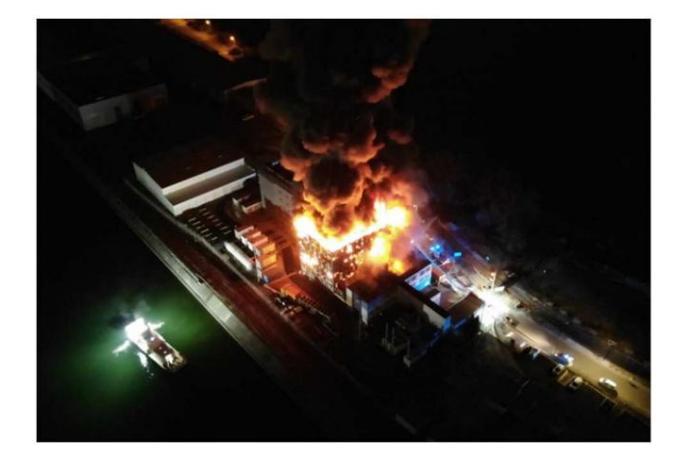
Photograph 4: Arrival of the Europa boat in the area (source SIS 67)

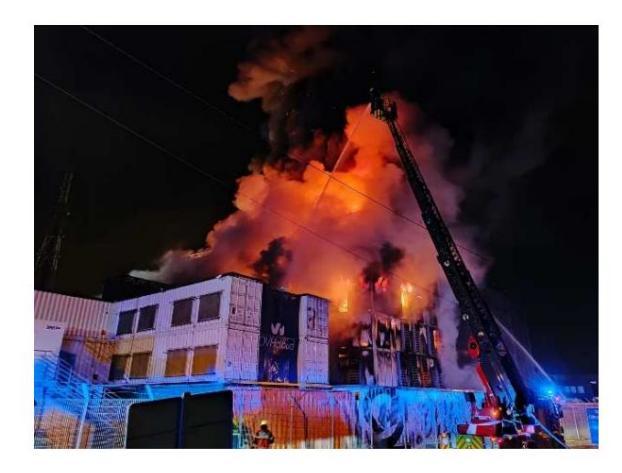
Photograph 5: Lance on automatic pivoting ladder (EPA) (source SIS 67)

EUROPA arrives on site at 02:57. Due to the deformations observed on the facade, a collapse of building 2 on itself is feared. The fire spread to building 1 and building 3. Two attack sectors were set up. A third sector is supplied by EUROPA. From 03:28, there is no more current on the site. At 6.45 a.m., the fire was brought under control, but extinguishing the residual fires was made difficult by the impossibility

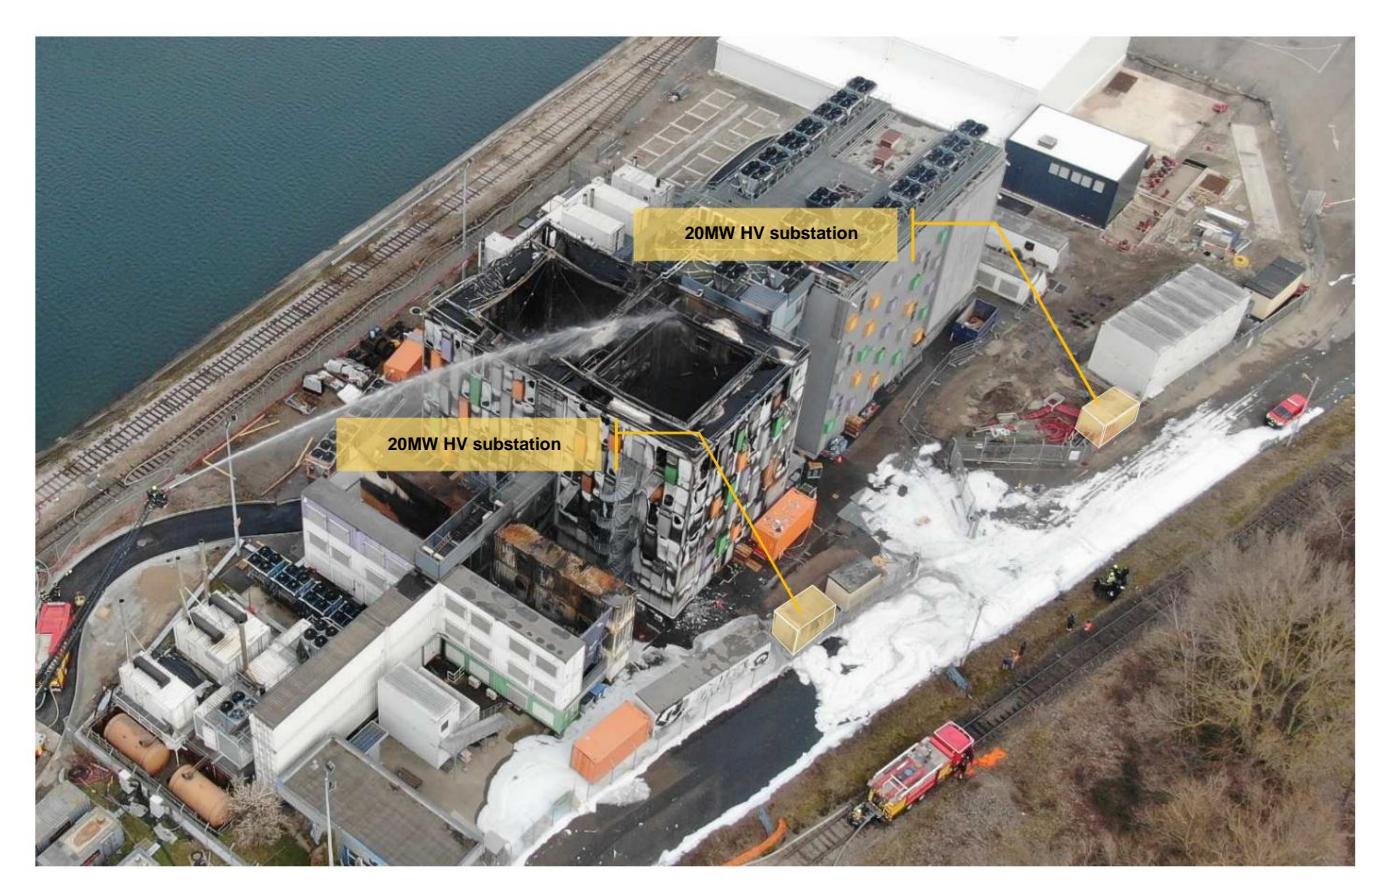
At 1:50 a.m., the site's power supply is cut off at the upstream source substation by RES (see point V.3). But at 02:14, there is still current in building 2, now totally ablaze, and a significant spread towards building 1 is observed.

Photograph: Location of 20 MW HV substations near buildings SBG2 and SBG3

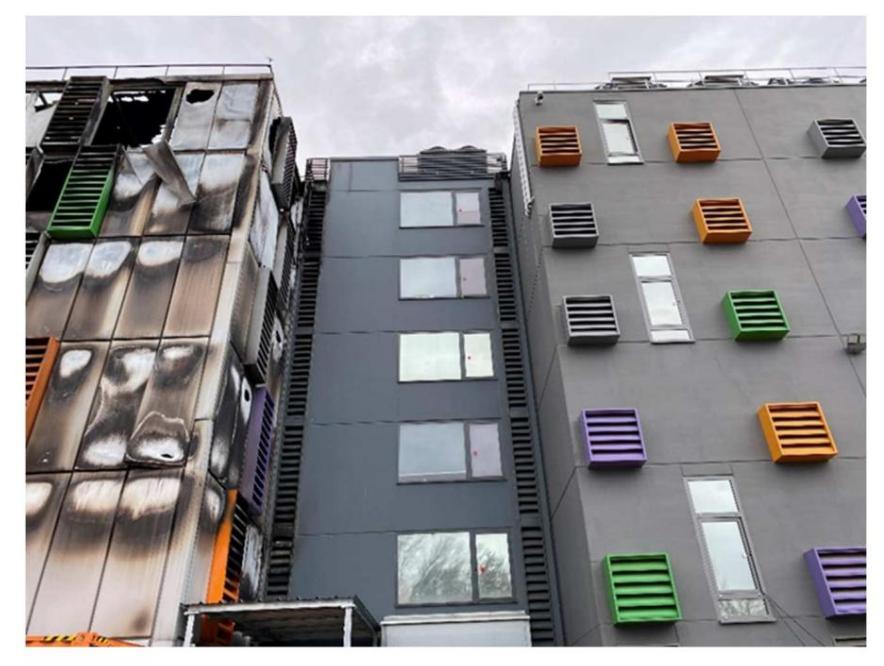
Although the SBG1 and SBG3 buildings have different technical and dimensional characteristics, we note however that SBG3, protected from SBG2 by 2-hour fire walls and by a separation (interbuilding zone made up of circulations), was less impacted than SBG1 which did not have the same level of protection (4 rooms destroyed out of 12). However, the emergency services reported to us that fire doors had been kept open during the evacuation, which had the effect of degrading the effectiveness of this system.

Photograph 10: area between SBG2 and SBG3

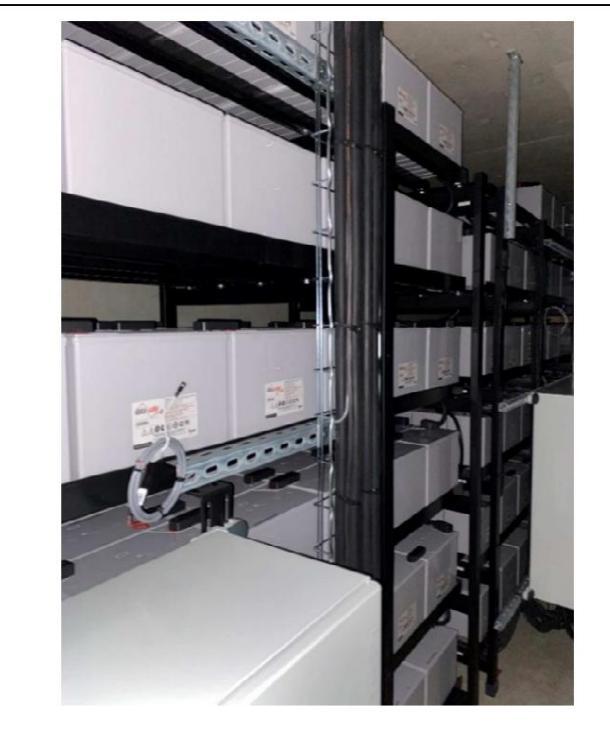
Photograph 11: Battery room of the type involved in the fire

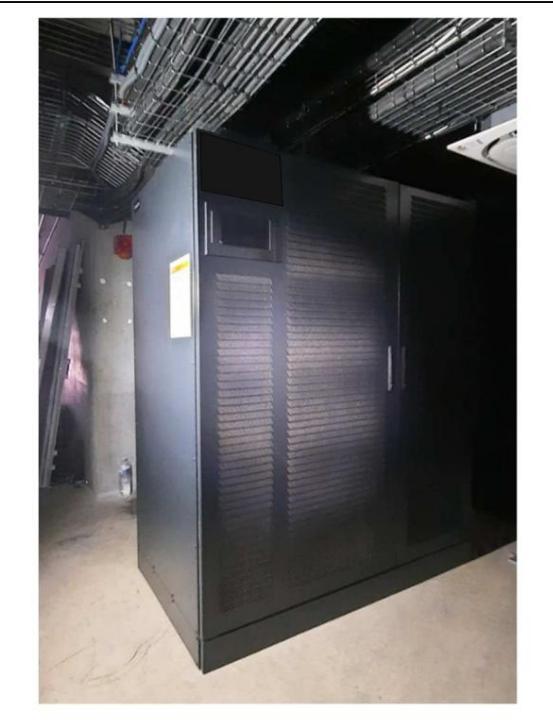
It is not possible, at this stage, to establish the cause of the failure at the level of the UPS which could be explained by various hypotheses (presence of liquid or humidity linked to the presence of the cooling system located nearby, malfunction linked to the maintenance operation carried out the same morning, operation of the inverter outside the normal operating ranges, etc.).

Photograph 12: uninterruptible power supply system (UPS) similar to that involved in the fire
